National Register of Historic Places Registration Form

Historic Name: Buena Vista Ranger Station
Other Names/Site Number: Buena Vista Guard Station/5CF828
Name of related multiple property listing: N/A

Street & Number: 410 East Main Street
City or town: Buena Vista State: CO County: Chaffee
Not for Publication: Vicinity:

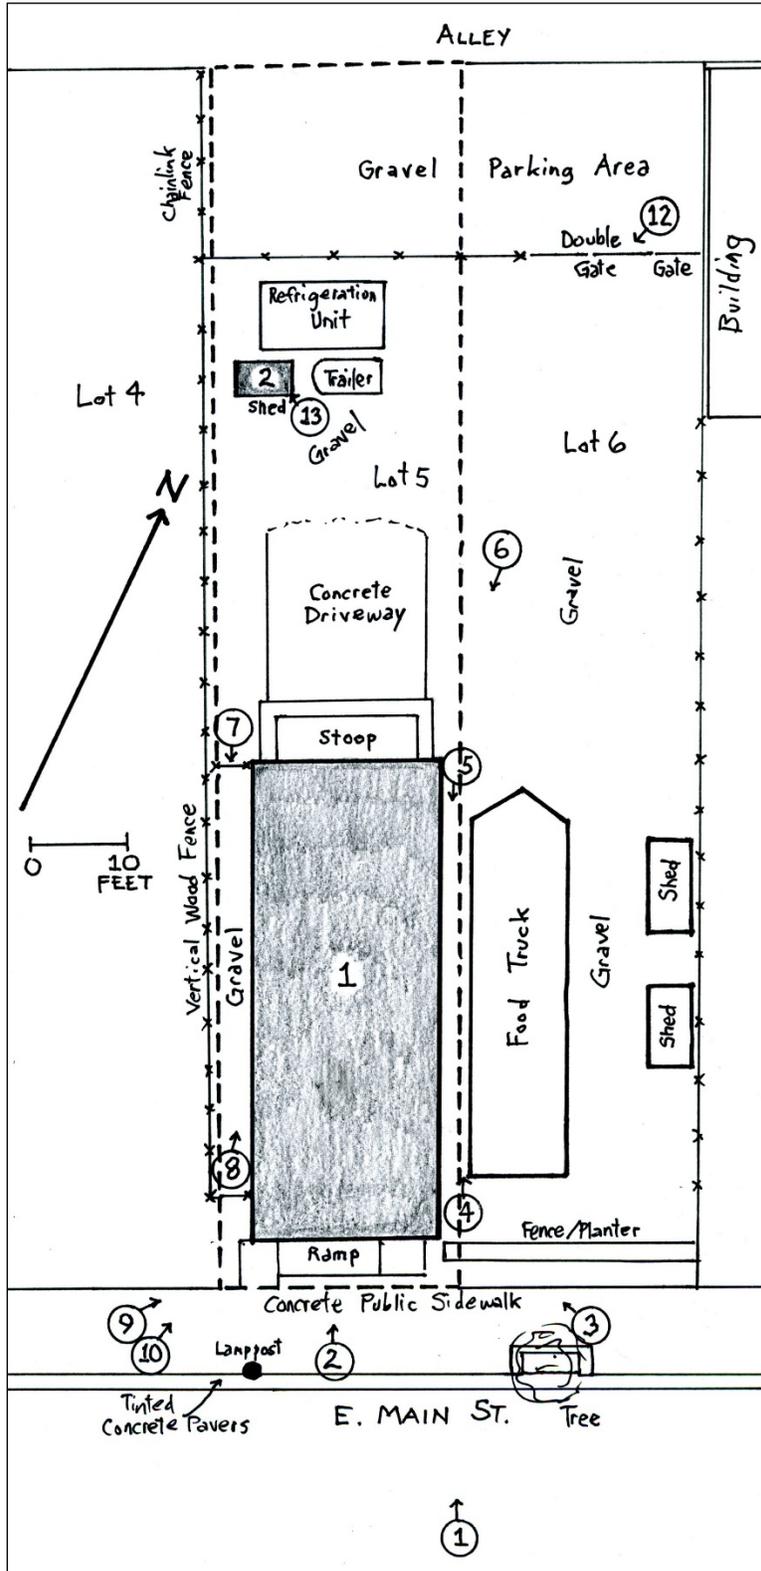
Sketch Map

The dashed line indicates the nominated area boundary; only Lot 5 is included. Numbers in circles show photograph locations and camera directions. Resource 1 is the ranger station and Resource 2 is a nonhistoric shed.

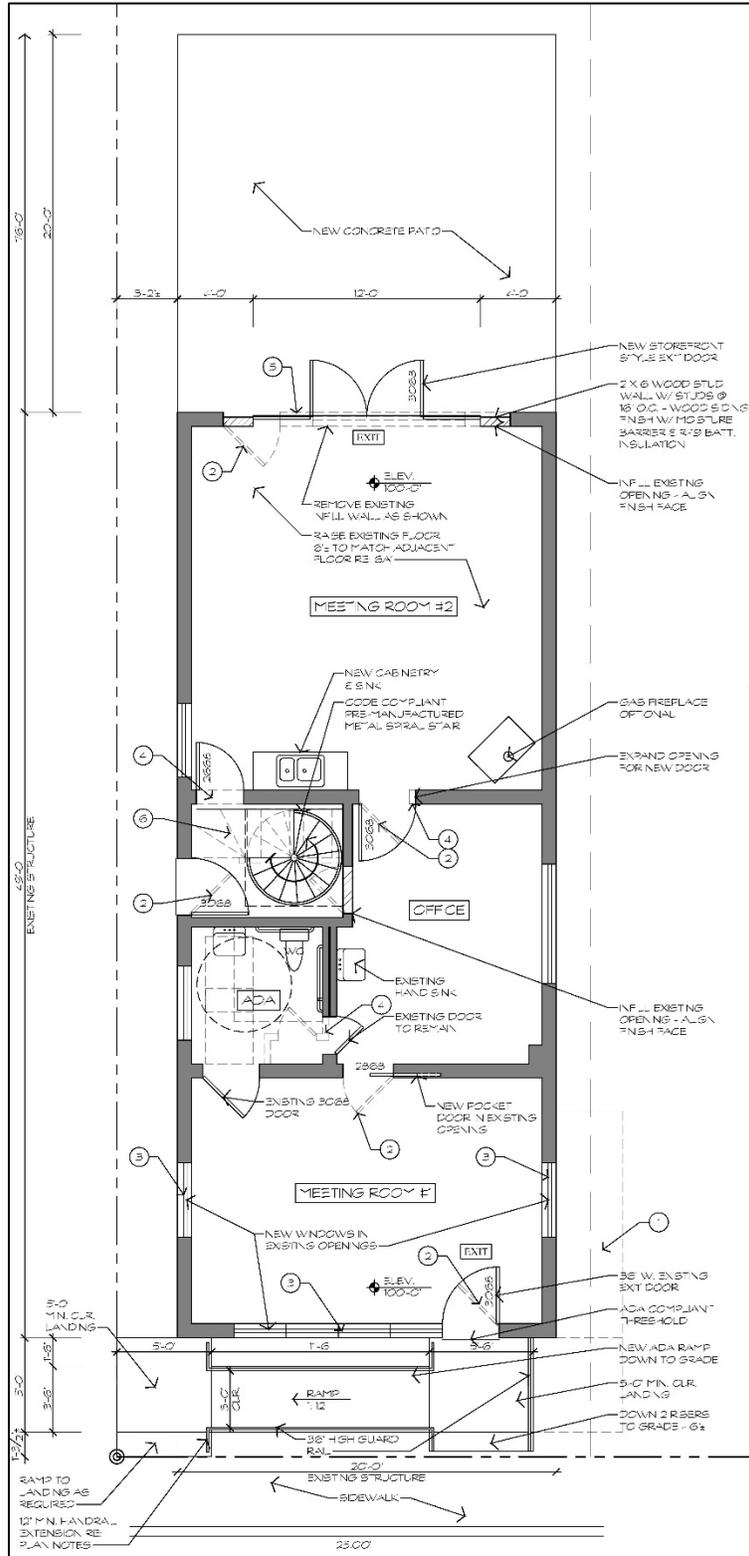
Figure 1. This 2018 construction drawing prepared for the remodeling and reuse of the building shows the interior floorplan. East Main Street is at the bottom of the drawing. The partial basement is only under the center part of the building. SOURCE: Sarah Weddington Architectural Services, The Ranger Station Renovation, construction drawing, January 12, 2018.

Interior. Figure 1 provides the current floorplan of the building. The full-width front room (the former ranger's office) is now a retail display area for the current tenant. The ceiling exhibits starburst designs carved in the original Celotex panels at the east and west ends (Photograph 11). The center section of the interior contains a work area, a bathroom, and access to the partial basement by a circular stairway. The large rear room (the former garage bay) is open and features red brick walls and exposed wood joists and roof deck boards. A partial basement in the center of the building is accessed by a metal circular staircase (nonhistoric) and contains a restroom and storage space.

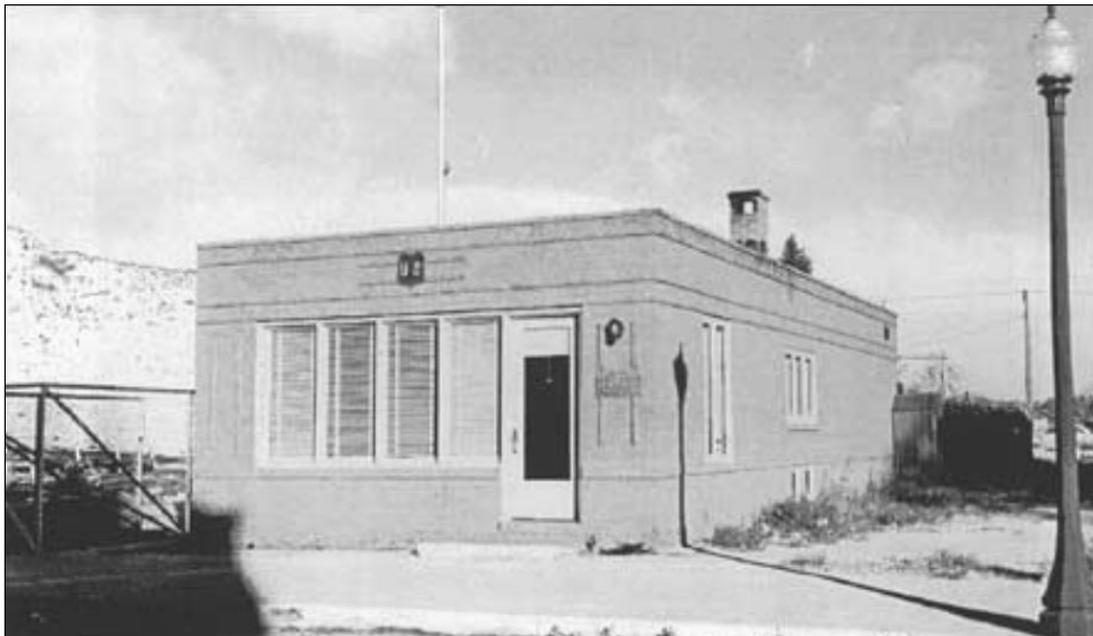
Figure 3. This 1939 photograph of the Buena Vista ranger station (view north-northwest) shows the front (south) and east walls of the building shortly after its completion. SOURCE: US Forest Service photograph, October 1939, in Hartley and Schneck, *Administering the National Forests of Colorado*, 158.

In December 1935 the federal government acquired a single town lot (Lot 5) from local resident George M. Pyle, Jr. Regional Forester Allen S. Peck recommended that workers from the Trout Creek CCC camp (number F-24) assist in the construction, but this does not appear to have occurred. The ranger station is not identified as a Works Projects Administration (WPA) effort.²⁷ According to Forest Service records, bricks for the building came from Delta, Colorado. The Buena Vista ranger station was completed by 1937, and a Forest Service photograph shows the finished building in 1939 (Figures 3 and 4).²⁸

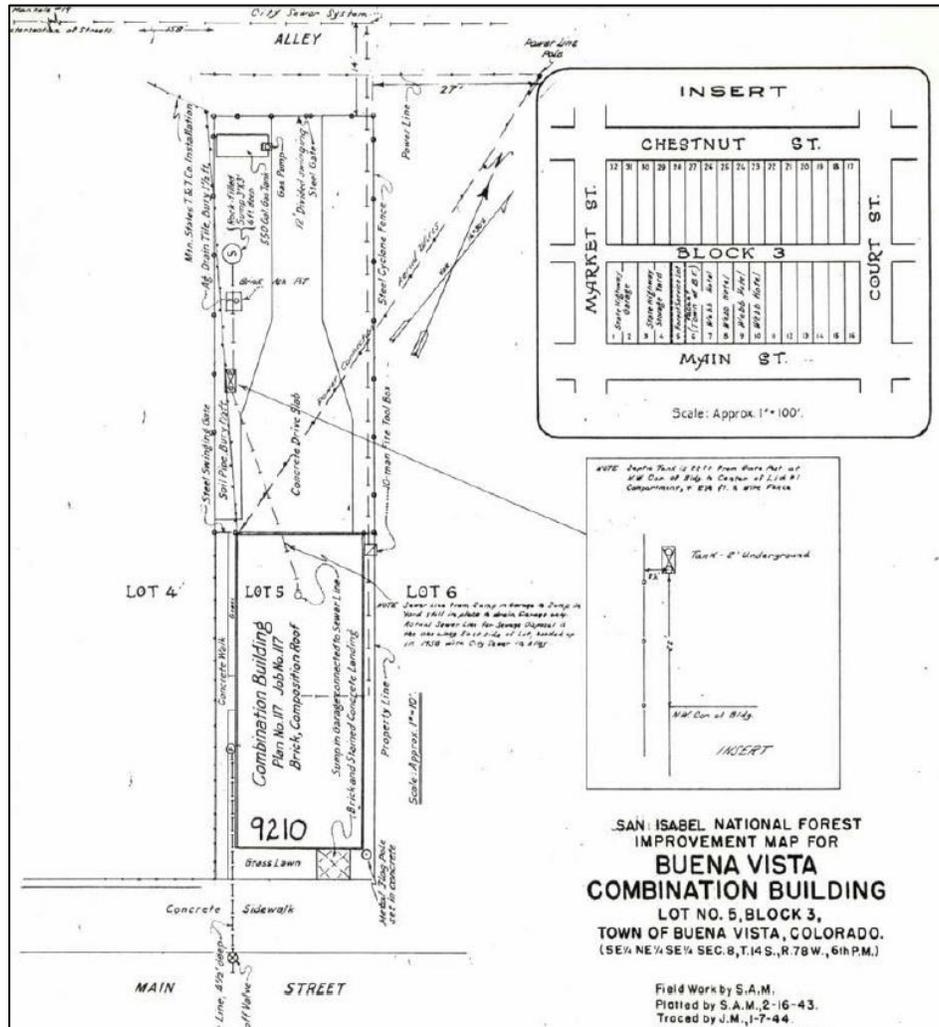
Figure 4. The ranger station is shown in the context of its lot in this 1943 plan drawing. The flagpole, ash pit, and gasoline tank are no longer extant. SOURCE: Buena Vista Combination Building, Plan Drawing, 1943 (revised through 1958), in Hartley and Schneck, 410 E. Main Street, 5CF828, Management Data Form, July 17, 1994.

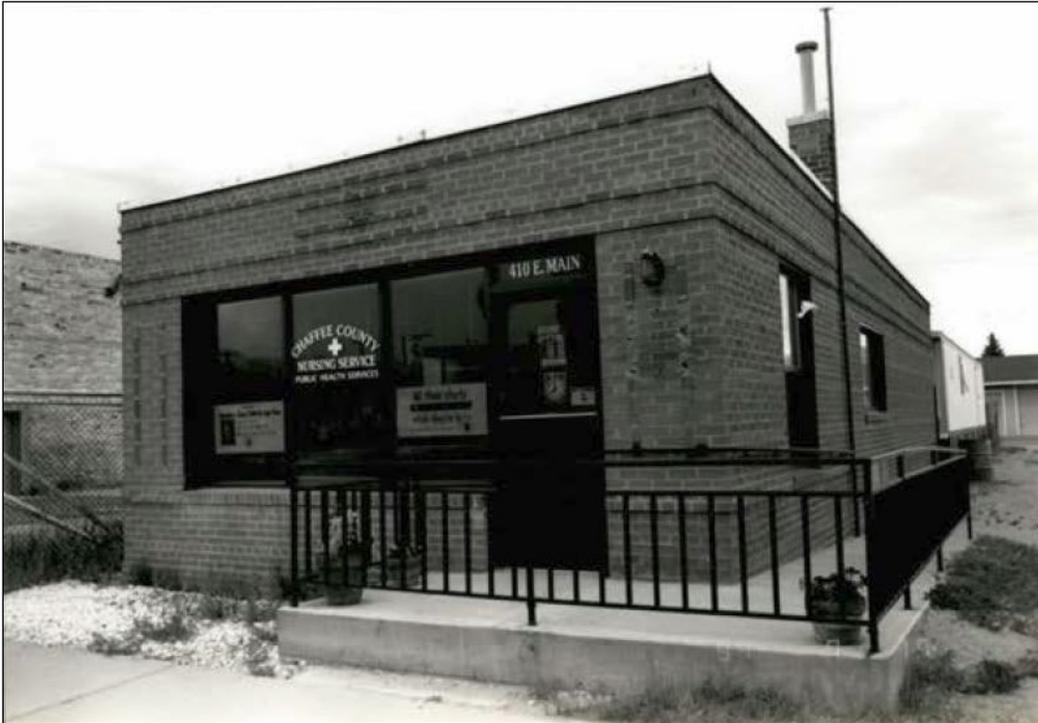
Figure 5. The Chaffee County Nursing Service still occupied the building in 1994. The building had received replacement door and windows (three fixed windows instead of four on the front) and a pedestrian ramp by that time. SOURCE: Hartley and Schneck, survey photograph July 17, 1994.

5 of 5, The Chaffee County Nursing Service still occupied the building in 1994. The building had received replacement door and windows (three fixed windows instead of four on the front) and a pedestrian ramp by that time. SOURCE: Hartley and Schneck, survey photograph July 17, 1994.
