National Register of Historic Places Registration Form

parameter and the second secon			
1. Name of Property			
Historic Name: McFadden Barn			
Other Names/Site Number: 5CF3572	A. (A		
Name of related multiple property listing	ng: N/A

Summary Paragraph

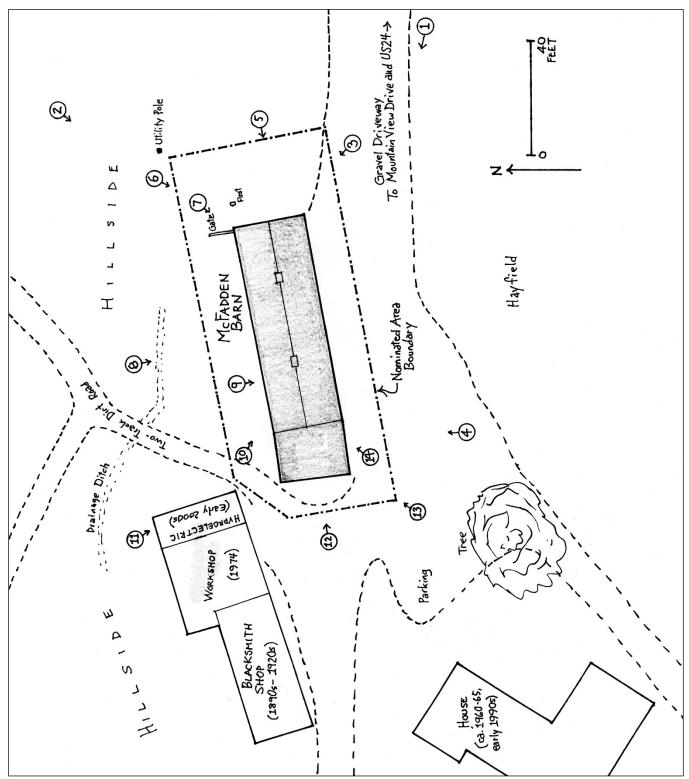
Sketch Map

The dotted-and-dashed line indicates the nominated area boundary. Numbers in circles show photograph locations and camera directions. The area east of the barn once held what one of the current owners believes was a horse holding area.

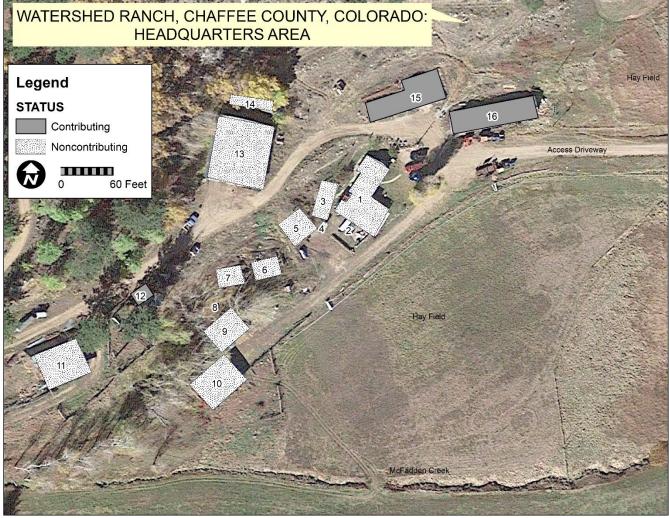
Overview Sketch Map of Ranch Headquarters

The location of the nominated barn (resource number 16 on this intensive survey map) is shown within the context of the McFadden Ranch headquarters. Evaluations of the potential contributing status of each resource in the headquarters area is shown by the indicated shadings, with 12 assessed as noncontributing and 4 as contributing. Resource15, northwest of the barn, is a historic blacksmith shop with a 1970s concrete block eastern section added to house hydroelectric equipment. SOURCE: Modified intensive survey map, T.H. Simmons and R.L. Simmons, McFadden/Morrison Ranch, 5CF.3417, Architectural Inventory form, March 2021; base map, Google Earth imagery, October 14, 2017.

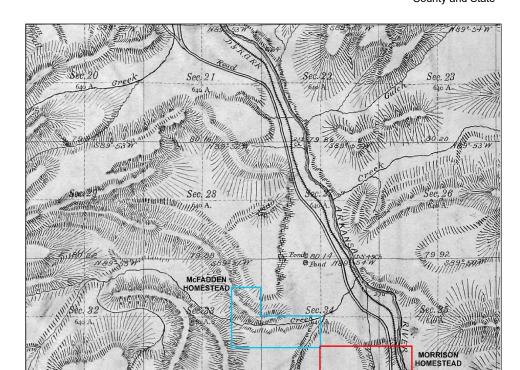
Figure 1. The boundary of the 1881 McFadden homestead is displayed here over the 1880 US Surveyor General's original township survey plat. The McFadden's later acquired the 1876 Morrison homestead to the southeast. The base map shows the location of the wagon road and Denver & Rio Grande Railroad tracks on the west bank of the Arkansas River. SOURCE: extract of US Surveyor General, original survey plat, Township 12 South, Range 79 West, 6th Principal Meridian, November 3, 1880.

In November 1881 McFadden settled on 160 acres of land west of Morrison's land and filed a homestead claim intention in January 1882 (Figure 1). During the same month, he diverted water for the McFadden Ditch, which took water from a headgate on the north bank of McFadden Creek (Ditch Number 85, named for William) in the Northeast Quarter of the Southwest Quarter of Section 33. The water right for the ditch was adjudicated in 1890, when it received priority number 96.²⁰ In addition to William P., the McFadden family then consisted of his wife, Margaret "Maggie" McFadden, and her daughter, Mary Ellen, born in 1881. Little could be found about Mrs. McFadden. She owned property in nearby Buena Vista and was involved in charitable work. One Ancestry.com family tree showed her maiden name as Diegnan (possibly a misspelling), and another suggested that Mary Ellen was Margaret's child from an earlier marriage. William P. McFadden became a US citizen in September 1887.

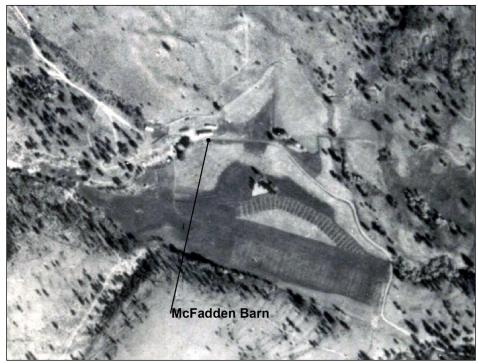
Figure 2. The barn stood in its current location within the McFadden Ranch headquarters in this 1938 aerial photograph. The area to the south and southeast are irrigated hayfields. SOURCE: Aerial photograph, number BOV 30-81, September 30, 1938, US Geological Survey, Earth Explorer, https://earthexplorer.usgs.gov.

The McFadden Barn was erected 1900-01, a date based on dendrochronological analysis, and is shown on a 1938 aerial photograph of the area (Figure 2).⁴ The rectangular (81' x 20') barn faces south-southeast and consists of an original gabled roof section (68' x 20') on the east and a smaller (13' x 20'), lower, shed roof western section. The latter appears to be a historic addition.⁵ The foundation of the barn is dry laid fieldstone, although recent repair efforts have mortared some areas of the wall. The lower level of the building, accessible from the south, has two open bays for vehicle and other storage to the west, and an enclosed east section. The upper level of the barn is clad with flush horizontal tongue-and-groove boards with corner boards and is accessible by overhead sliding doors on the north, south, and east walls. The barn has overhanging eaves, and the roof is clad with corrugated metal panels. There are two gabled roof cupolas with wood louvers on the roof ridge and lightning arrestors at each end of the ridge.⁶

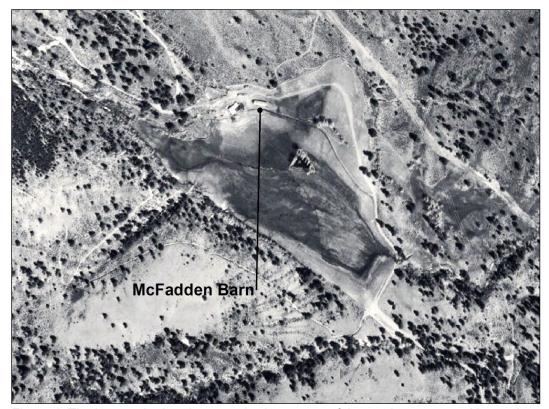
Figure 4. The barn at the headquarters is shown east of the newly constructed house in this 1965 aerial photograph. SOURCE: aerial photograph, BR382, TS 1-33, May 16, 1965, US Geological Survey, Earth Explorer, https://earthexplorer.usgs.gov.

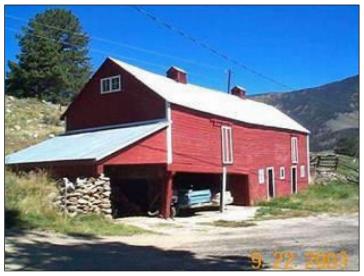
Figure 5. A September 2001 Chaffee County Assessor photograph showed the barn (view northeast) with the same appearance as today. SOURCE: Chaffee County Assessor, photograph, September 22, 2001.
