## COLORADO STATE REGISTER OF HISTORIC PROPERTIES NOMINATION FORM

Historic Name: Buckhorn Ranger Station Historic District

Other Names: Buckhorn Work Center, Old Buckhorn Ranger Station, 5LR.1862, 5LR.732

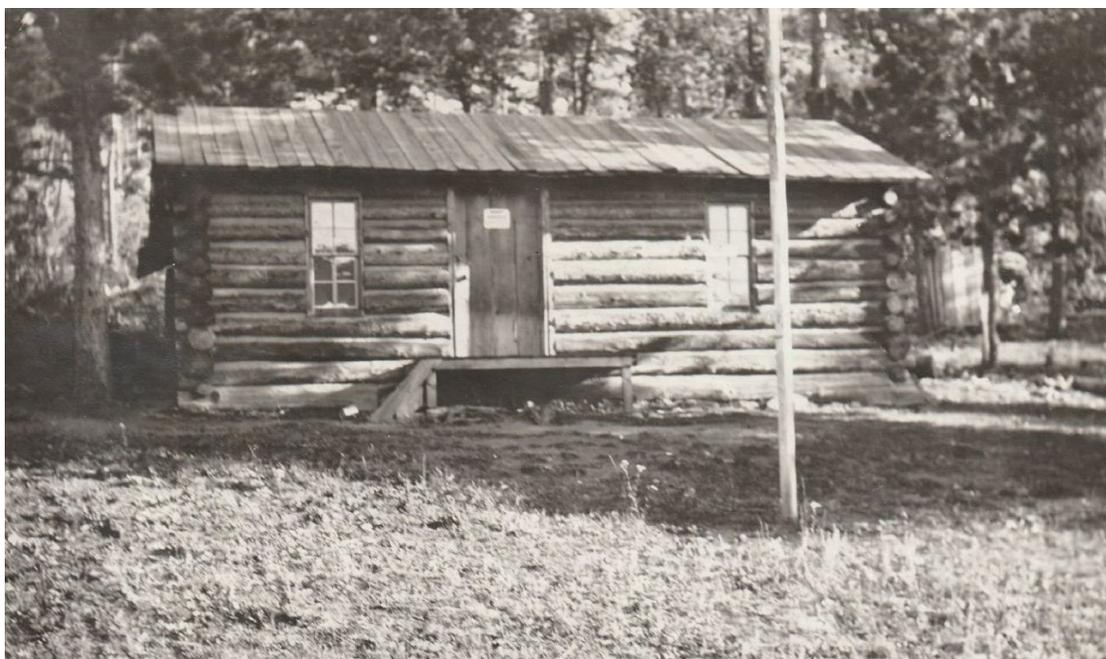
Figure 1: Photo of Old Buckhorn Ranger Station (5LR732), circa 1907, facing north. Source USFS Historic Ranger Stations Scrapbook.

The 1906 Buckhorn Ranger Station site (5LR.732) consists of a stone and earth cellar, building foundations, an artifact concentration, scattered historic artifacts, and the remains of a historic entrance road. The stone cellar is in good condition, although the sod roof is no longer present. A photo of the 1906 log cabin shows that it was likely less than 20' long with two four-over-four double hung windows on either side of a wooden plank door. The building appears to have saddle notched logs with a stone foundation. Only some short linear alignments of stone foundation remain at the current site. Later photos and paintings show that three additions were added to the first log cabin. A 1938 map of the site shows that the Ranger Station was converted, or planned for conversion, into a tool room and a garage (Historic Plans and Maps, Figure 2). The 1938 plot map shows the location of the cellar and a toilet 195' east of the cellar. In the 1930s when the CCC was building the new Ranger Station south of the 1906 location there was a CCC side camp located at the site. The side camp had at least one large wood framed bunkhouse or crew quarters. A 1938 aerial photograph (USFS, 1938) shows the crew quarters building south of the 1906 log cabin, but a 1961 photo shows a crew quarters building near where the toilet is shown on the 1938 plot map.

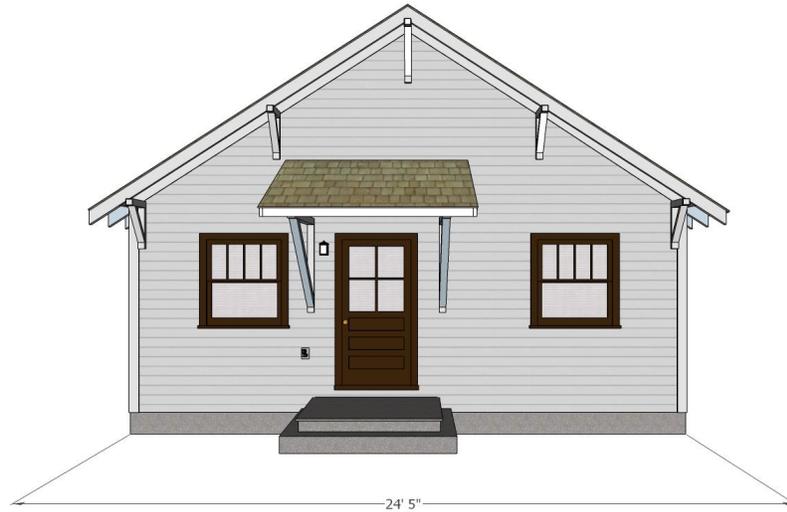
Figure 4: Measured drawing of north elevation of Ranger Dwelling.

The north side of the Ranger Dwelling (front) measures 24'-5" from east to west and has two four-over-one double-hung wood windows on either side, a three-panel wood door with four lights, and a non-historic brown-metal storm door, and an extending 5' awning with cedar shingles constructed with 4"x4" beams over two concrete steps.

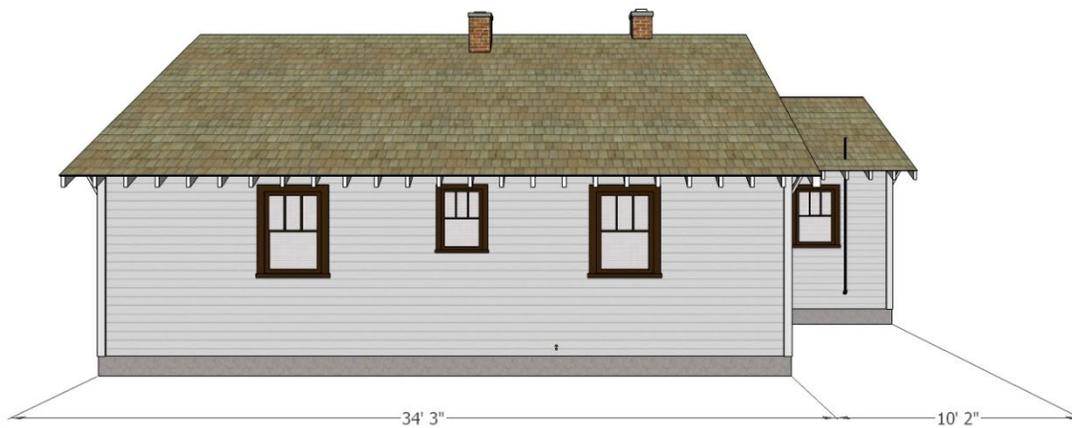
Figure 5: Measured drawing of west elevation of Ranger Dwelling.

The west side of the building measures 34'-3" and has two larger three-over-one wood double-hung windows in the bedrooms and one smaller three-over-one double-hung window in the bathroom. The west side wall of the addition extends 10'-2" and has one larger three-over-one double-hung window.

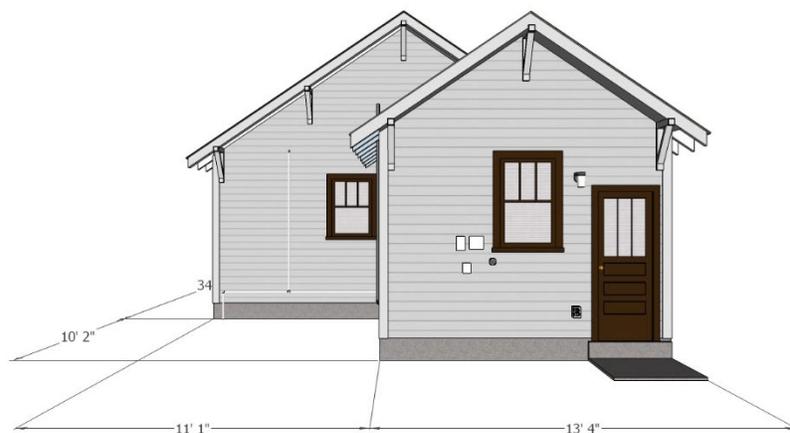
Figure 6: Measured drawing of south elevation of Ranger Dwelling.

The south side of the building has an 11'-1" wall with one three-over-one double-hung window in the bedroom, one three-over-one double-hung window near the center of the addition that extends to the south of the main building on the east side of the rear wall, and a three-paneled wood door with three lights (oriented vertically). The south wall (rear) door does not have a storm door.

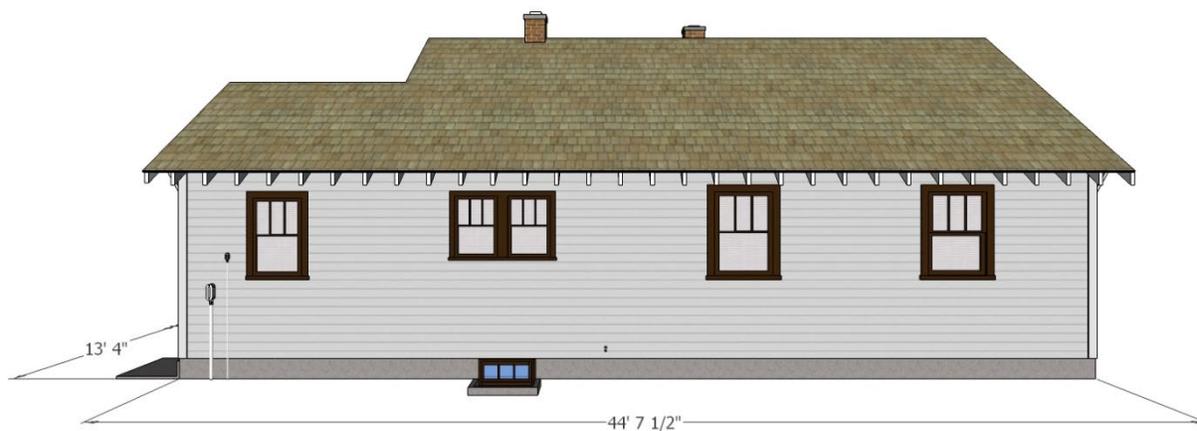
Figure 7: Measured drawing of east elevation of Ranger Dwelling.

The east side has three three-over-one double hung windows and two smaller paired three-over-one double-hung windows connected with a center rail. Two of the larger windows are located on the north portion of the east wall in the living room and one is located on the southern portion of the east wall in the addition. The smaller windows are in the kitchen on the south side of the main building, adjacent to the addition. One three-light casement window is in the basement at the foundation below the kitchen windows.

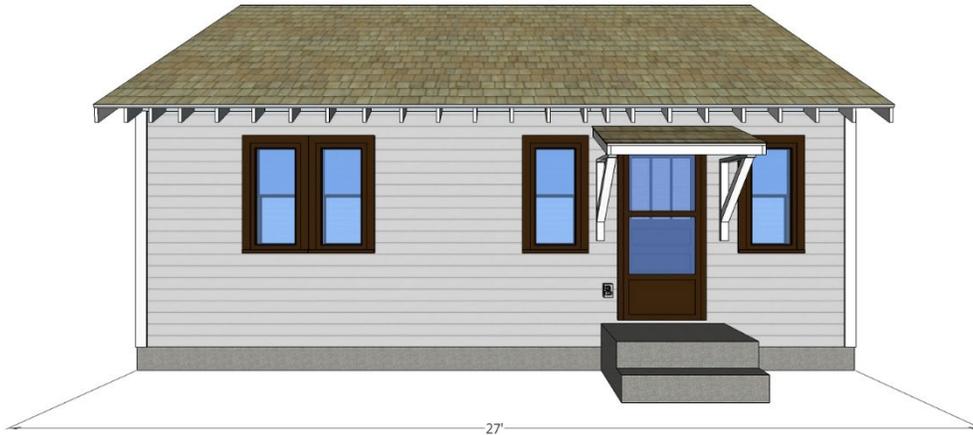
Figure 8: Measured drawing of north elevation of Assistant Ranger Dwelling.

The north side of the Assistant Ranger Dwelling (front) measures 27' from east to west and has two one-over-one wood double-hung windows on either side, a three-panel (horizontally oriented) wood door with three vertical lights and a non-historic brown-metal storm door and an extending 5' awning with cedar shingles constructed with 4"x4" beams over two concrete steps. There are two additional paired one-over-one double hung windows connected with a center rail on the eastern portion of the north side.

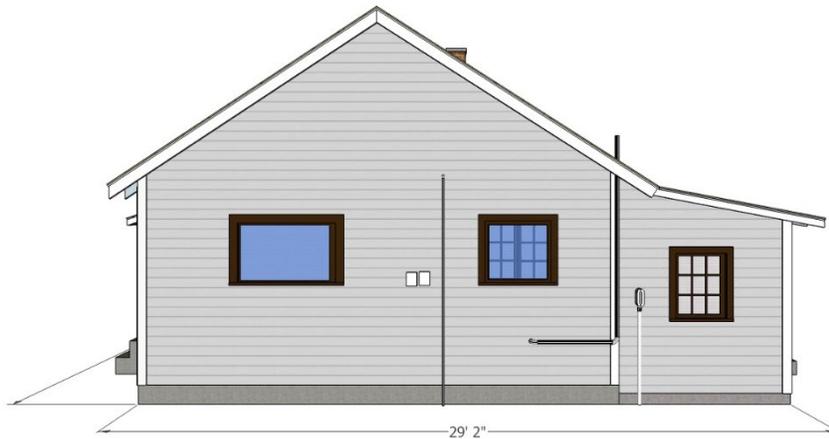
Figure 9: Measured drawing of west elevation of Assistant Ranger Dwelling.

The west side of the building measures 29'-2" and has one fixed pane non-historic window and one horizontal sliding sash window; each sash has six lights. There is an 8' shed addition on the southern portion of the west side with one fixed nine light window centered on the addition wall.

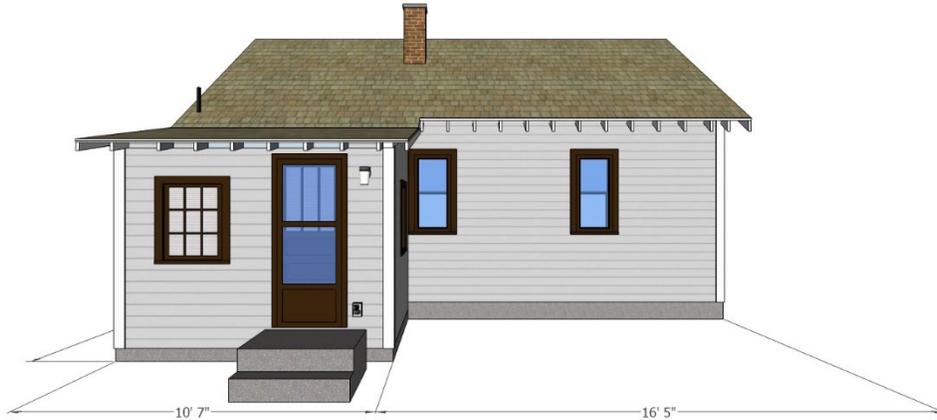
Figure 10: Measured drawing of south elevation of Assistant Ranger Dwelling.

The south side of the building (rear) has a 10' 7" addition and a 16' 5" wall on the primary structure. The addition has a fixed nine light window to the left of a three-panel wood door with three vertical lights and a non-historic brown-metal storm door. The main structure has two one-over-one double hung windows.

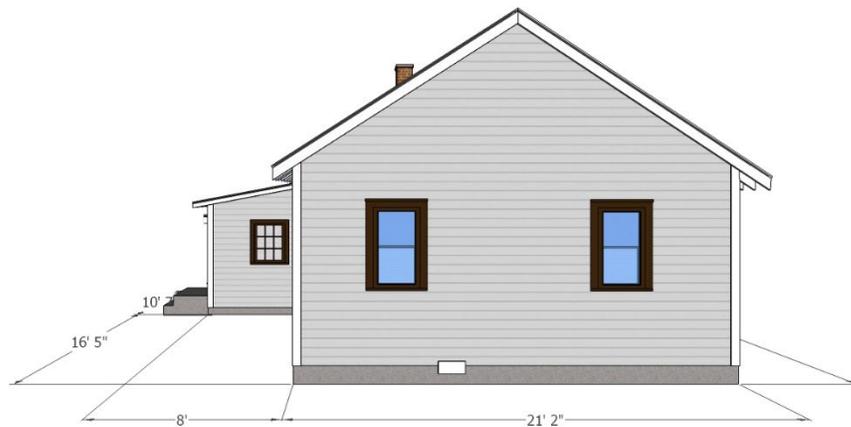
Figure 11: Measured drawing of east elevation of Assistant Ranger Dwelling.

The east side of the building measures 21' 2" and has two one-over-one double hung windows. The shed addition extends 8' to the south and has one fixed nine light window. All the double hung exterior windows have historic wood storm windows.

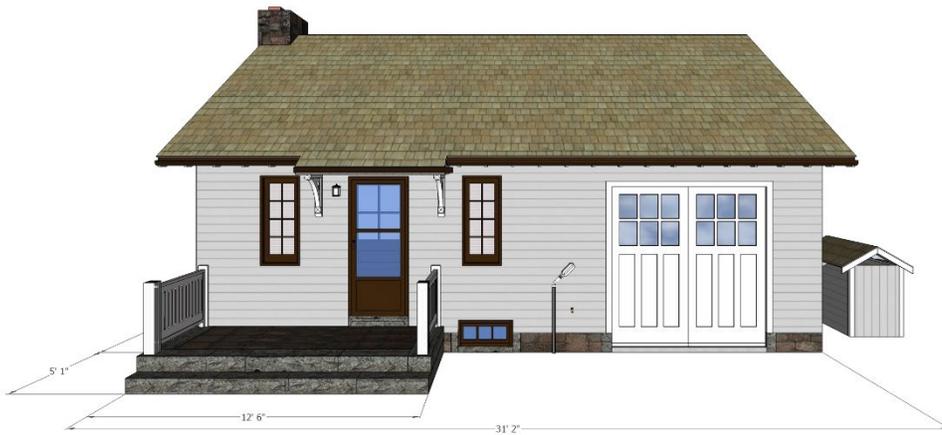
Figure 12: Measured drawing of west elevation of Office.

The west side of the building (front) measures 31'-2" from north to south and has two in-swinging casement windows on either side of a three-panel wood door with four lights, and a non-historic brown-metal storm door and a roof extension over the door that measures 6' wide and extends out 1'9". A 12' x 5' stone porch is located on the north side of the building with two steps and wooden railings on the north and south sides. There is one hopper window directly under the south window. There is a small one bay garage with two three-panel doors to the south of the entrance. There is more detailing on porch railings, gate bay doors, and the roof overhang than on other buildings at the site.

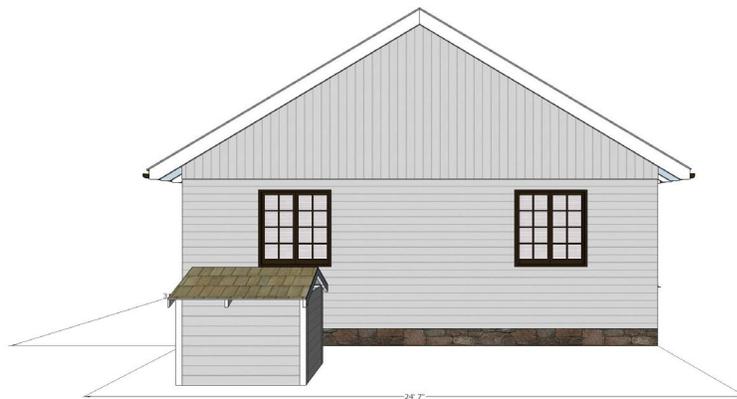
Figure 13: Measured drawing of south elevation of Office.

The south side of the Office measures 24'-7" and has two in-swinging eight light casement windows with rabbited canter rails. There is a small generator outbuilding just east of the southwest corner. The Generator House was not present in any photos prior to or including the early 1980s.

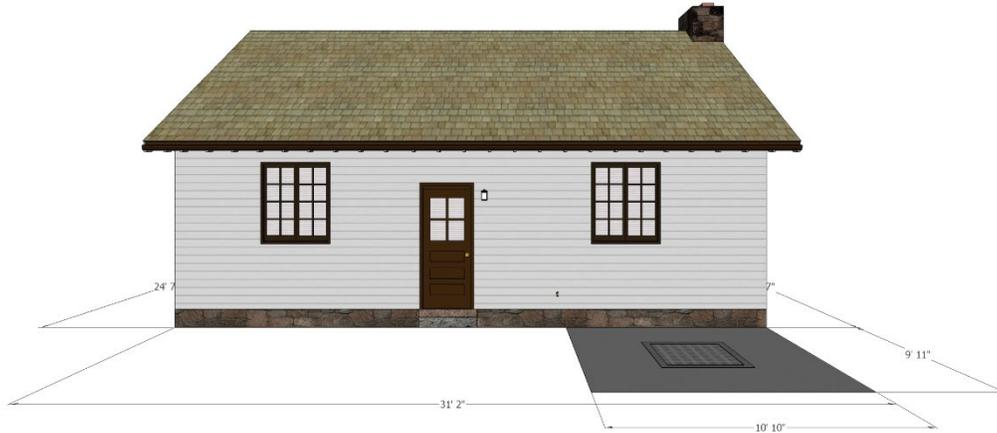
Figure 14: Measured drawing of east elevation of Office.

The east side of the building measures 31'-2" and has one three panel wood door with three lights and two in-swinging eight light casement windows with rabbited center rail that flank the rear door. There is a basement engine room or light plant on the northern portion of the east side that has glass block windows in the ceiling. The rear door is a three-panel wood door with four lights. A modern storm door was installed but recently removed during efforts to protect the site from the 2020 Cameron Peak fire.

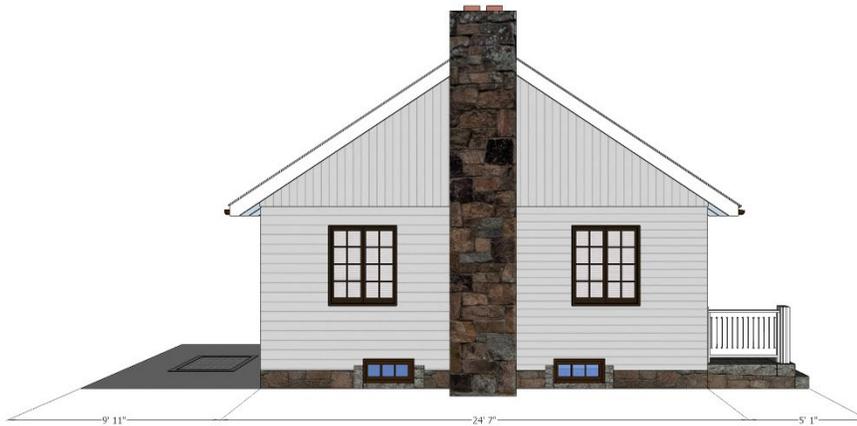
Figure 15: Measured drawing of north elevation of Office.

The north side measures 24'-7" and has two eight light in-swinging casement windows with a rabbited center rail on either side of a stone chimney, and two three-light awning windows in the basement level.

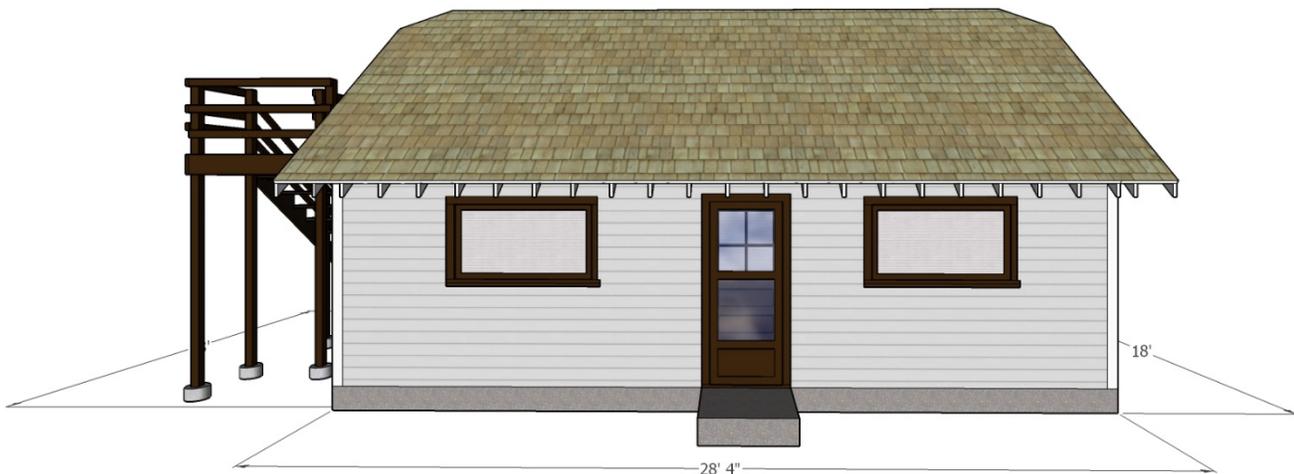
Figure 16: Measured drawing of south side of Bunkhouse.

The south side of the building (front) has a wood three-panel door with four lights and a non-historic metal storm door near the center of the wall and two single light fixed windows that flank the entrance.

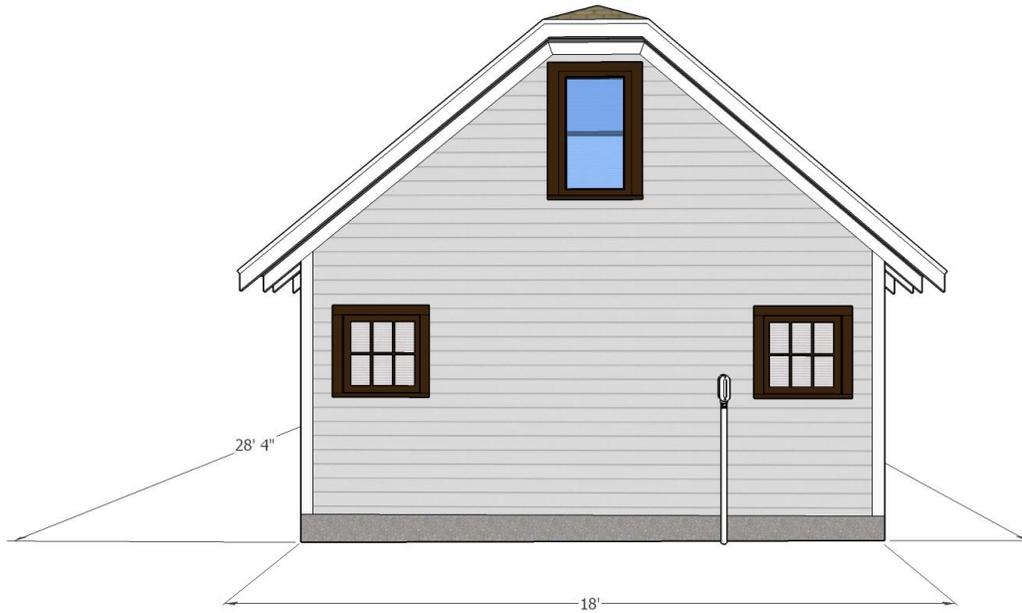
Figure 17: Measured drawing of east side of bunkhouse.

The east side has two fixed six light windows on the main floor and one double hung one-over-one window on the second floor with a non-historic metal storm window. Both fixed windows have original wood storm windows present.

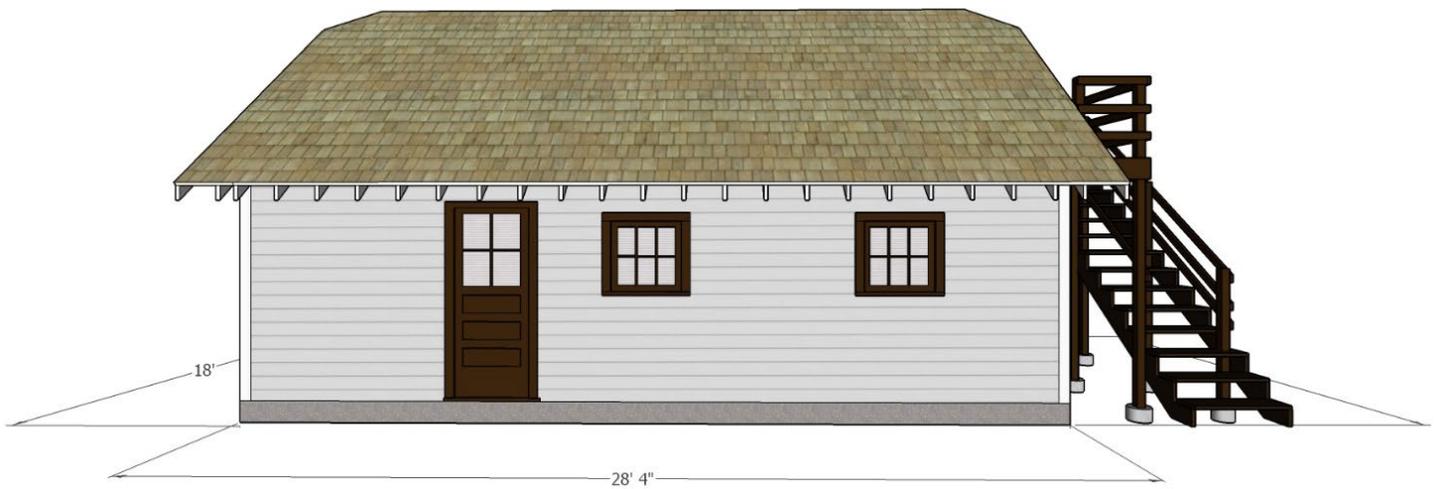
Figure 18: Measured drawing of the north side of the Bunkhouse.

The north side (back) has a three-panel wood door with four lights on the east portion of the wall and two six light fixed windows on the western portion of the wall. The west side window has the original wood storm window present.

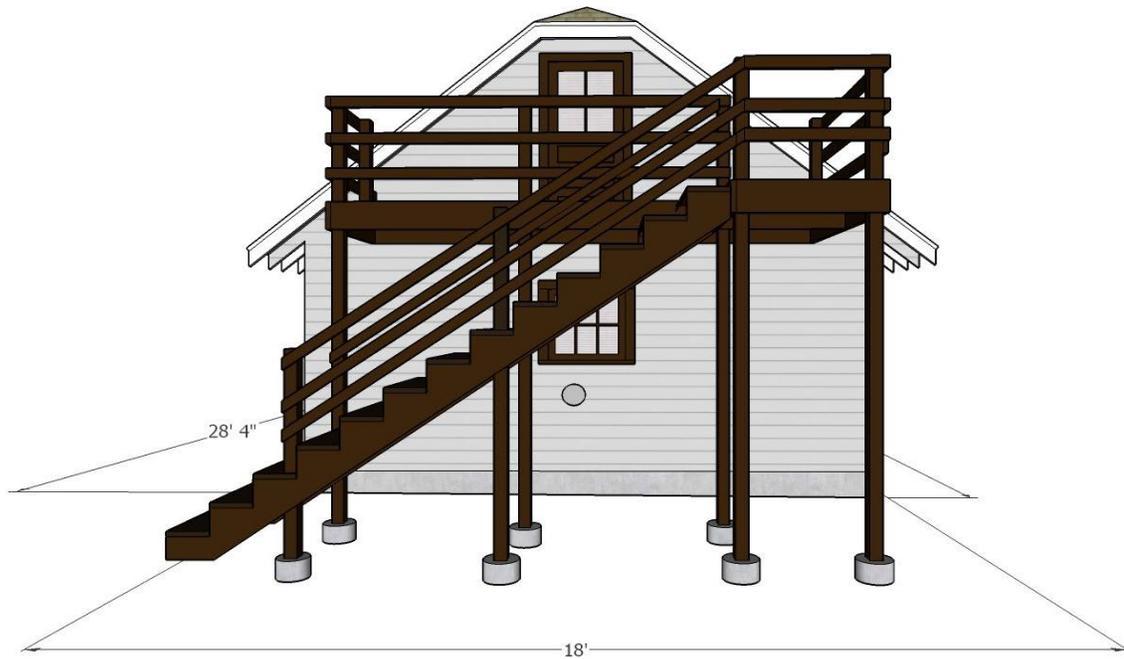
Figure 19: Measured drawing of west side of Bunkhouse.

The west side has a fixed three-light window on the main floor, a three-panel wood door with three lights on the second floor and a wooden deck and stairs that extend out seven feet from the wall. The window on the main floor has the original wood storm window present.

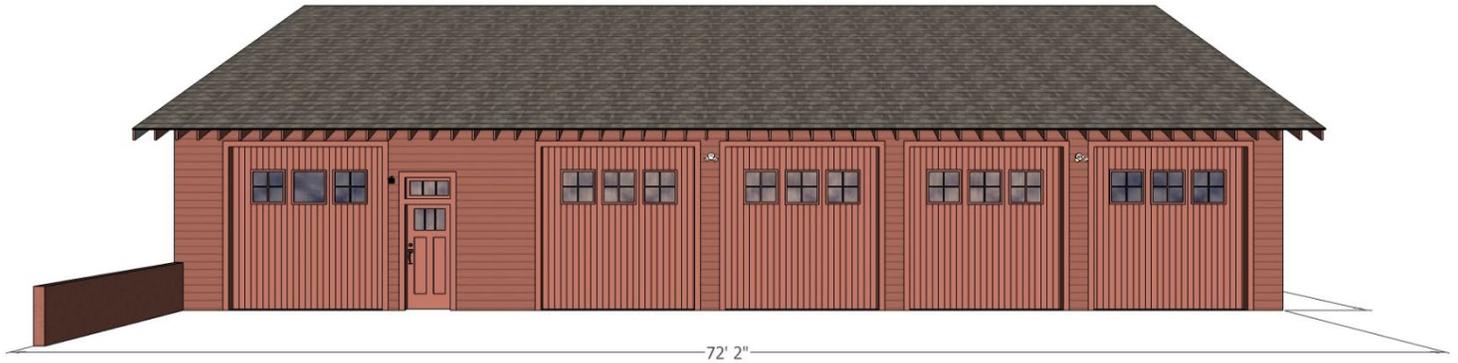
Figure 20: Measured drawing of west side (front) of Garage.

The Garage is a rectangular plan 1 ½ story building that measures 72'-2" x 32'-3", with side gables, horizontal wood drop siding, overhanging eaves, asphalt tabbed shingles, and a brick chimney. The west side has four main bays and a shop bay. The doors all measure 10' wide by 10'-6" tall and have three four light fixed windows in each bay door. The bay doors are constructed with tongue and groove vertical planks. To the north there is a two-panel door with three lights and a three light transom window above the door. North of the door is the shop bay door similar in design to the garage doors. The south side has two pairs of six-over-six light double hung wood windows and a single six-over-six light double window in the center on the second floor.

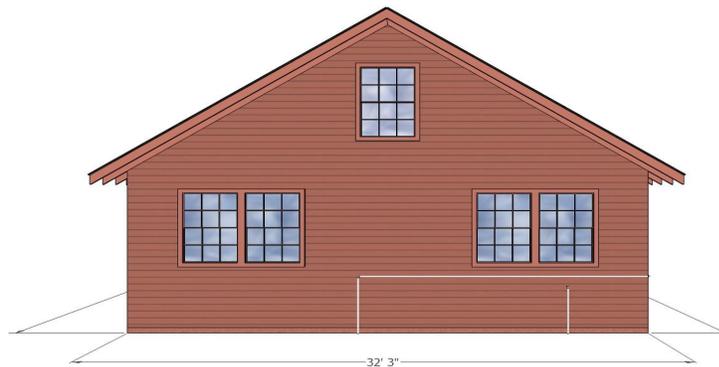
Figure 21: Measured drawing of south side of Garage.

The south side has two pairs of six-over-six light double hung wood windows and a single six-over-six light double window in the center on the second floor.

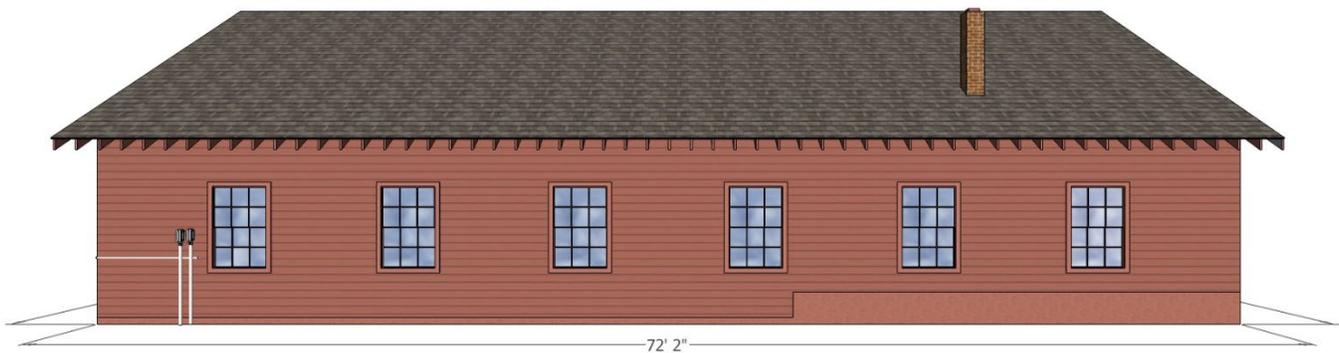
Figure 22: Measured drawing of east side of Garage.

The east side has six single six-over-six double hung windows, spread approximately every nine feet on the wall.

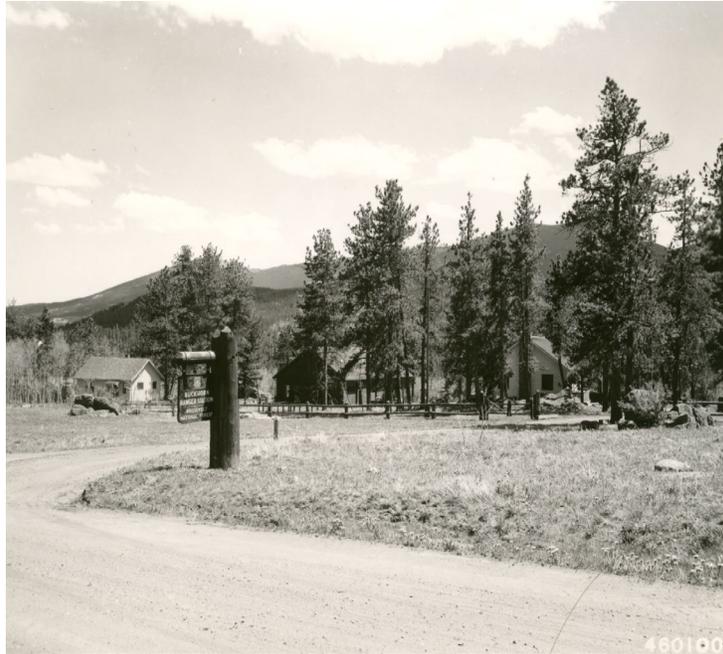
Figure 25: Photo of first entrance sign in 1950 installed in the 1930s. Source USFS Historic Ranger Station Scrapbook.

An entrance sign is located on the west side of the entrance road to the Buckhorn Ranger Station at the intersection with County Road 44H, Buckhorn Road. The sign is mounted on four square 7" x 7" posts. A 1950 photo shows a historic sign mounted on a large diameter log with a hanging sign. The sign matches styles that can be seen in the Albert Good, National Park Service Architectural Consultant book, *Park and Recreation Structures* (1938: Pages 12-13) and other historic signs used by the Forest Service in the 1930s through 1950s. The newer sign matches styles commonly seen Post WWII and the Operation Outdoors period (Alford 2014 and Arapaho and Roosevelt National Forest Signs Scrapbook). The Operation Outdoors period mirrored the National Park Service Mission 66 period programs (Forest Service, 2001: 15).

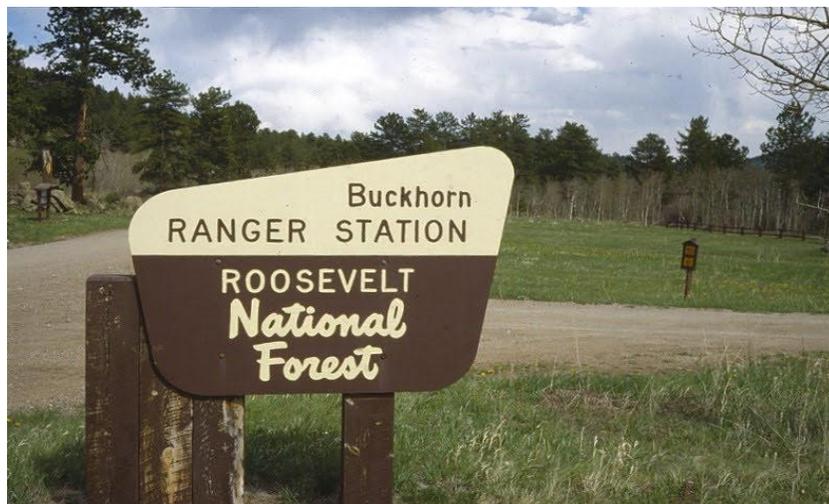
Figure 26: Photo of entrance Sign in 1988, installed in 1968. Source USFS.

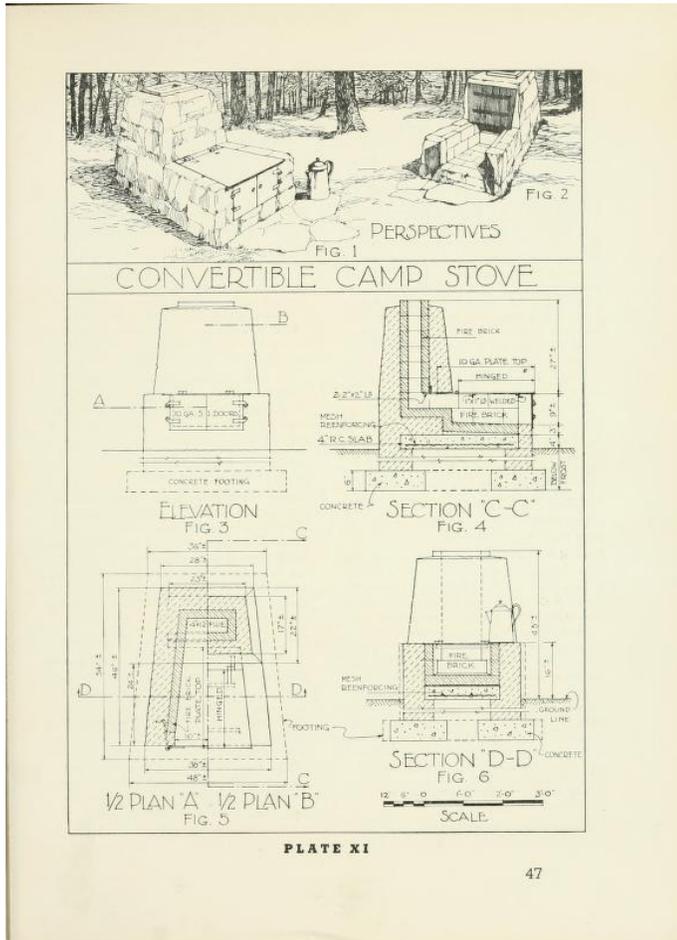
Figure 27: Design of Convertible Camp Stove from Plate XI in the 1937, *Camp Stoves and Fireplaces*, by A. D. Taylor.

A stone convertible camp stove is located 75' south of the west wall of the Ranger Dwelling. The stone fireplace has a chimney, foundation walls and a metal fire grate. The design of the fireplace is similar to one published in *Camp Stoves and Fireplaces* by A. D. Taylor in 1937. The construction guide was published by the CCC and the Forest Service. The fireplace at the Buckhorn Ranger Station is most similar to Plate XI on page 47. The grate on the Buckhorn Ranger Station Fireplace is shown on Plate III and Plate III-A (page 29 and 31) as the standard grate.

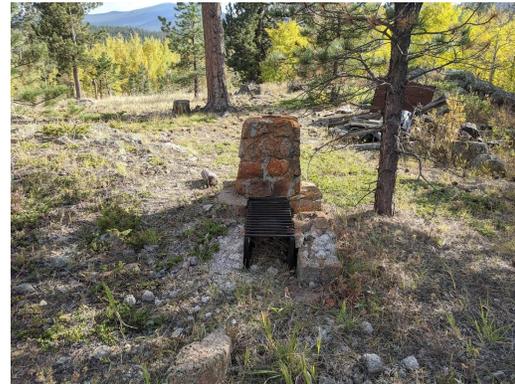
Figure 28: Buckhorn Ranger Station Convertible Camp Stove, facing south. Source USFS.

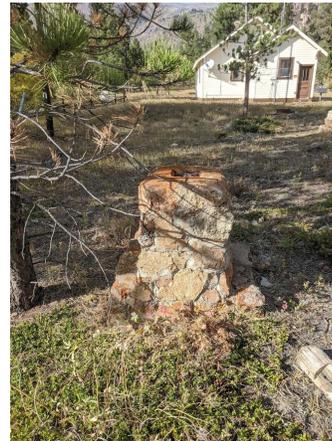
Figure 29: Buckhorn Ranger Station Convertible Camp Stove, facing north. Source USFS.

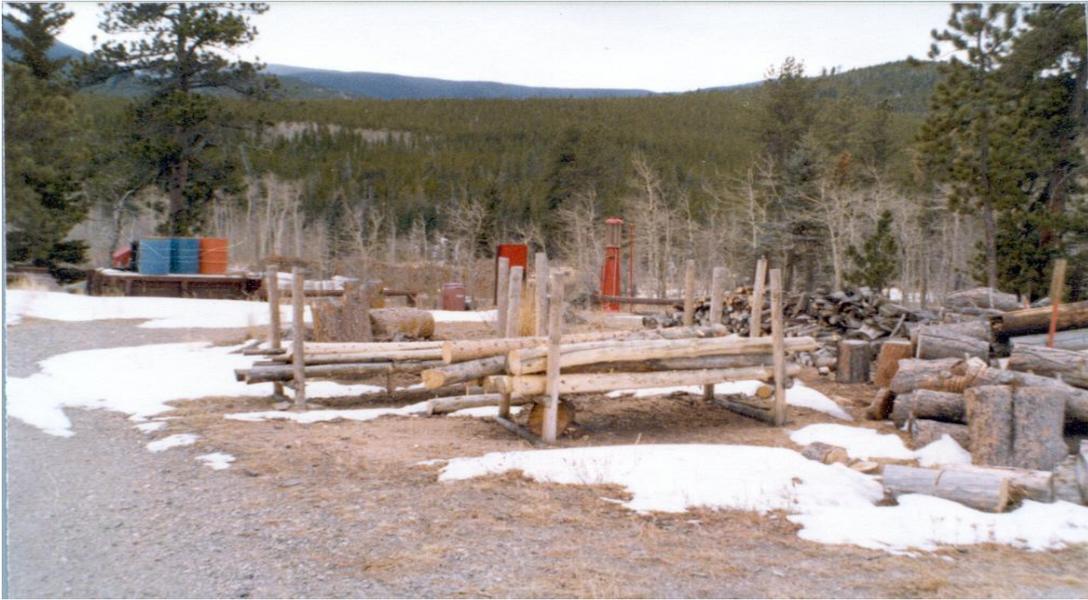
Figure 30: photo of non-extant gas pump ca. 1980s. Source USFS.

A gas pump is shown on the 1965 map of the site. The gas pump can be seen in a 1980s photo (Figure 25). The gas pump was located just under 200' south of the Ranger Dwelling and about 25' west of the loading dock. A later photo shows that the gas pump was replaced with two above ground gas tanks.

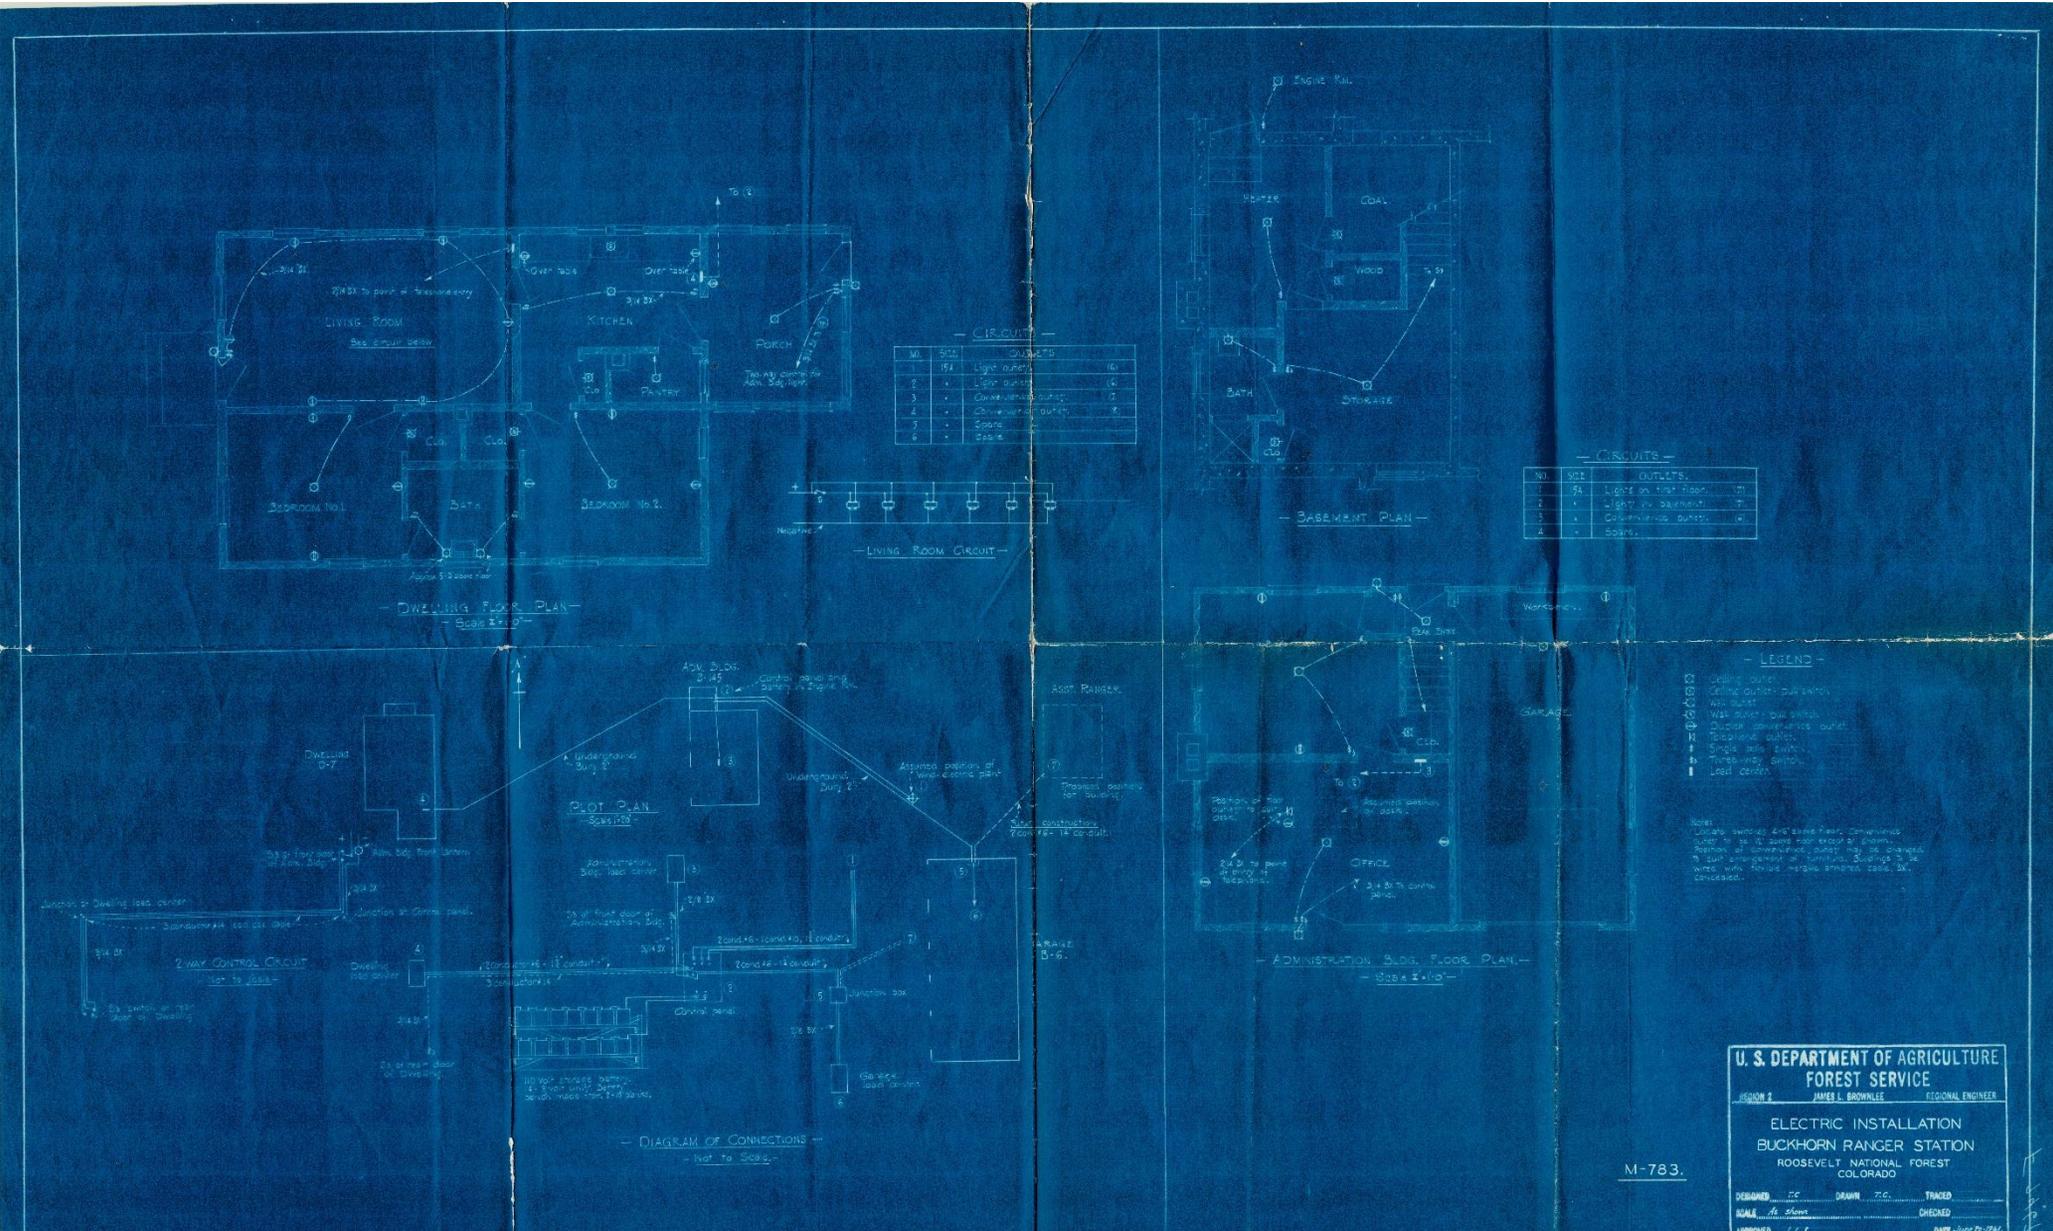
Figure 4m. Scanned "Electric Installation, Buckhorn Ranger Station" Blueprint (1941).

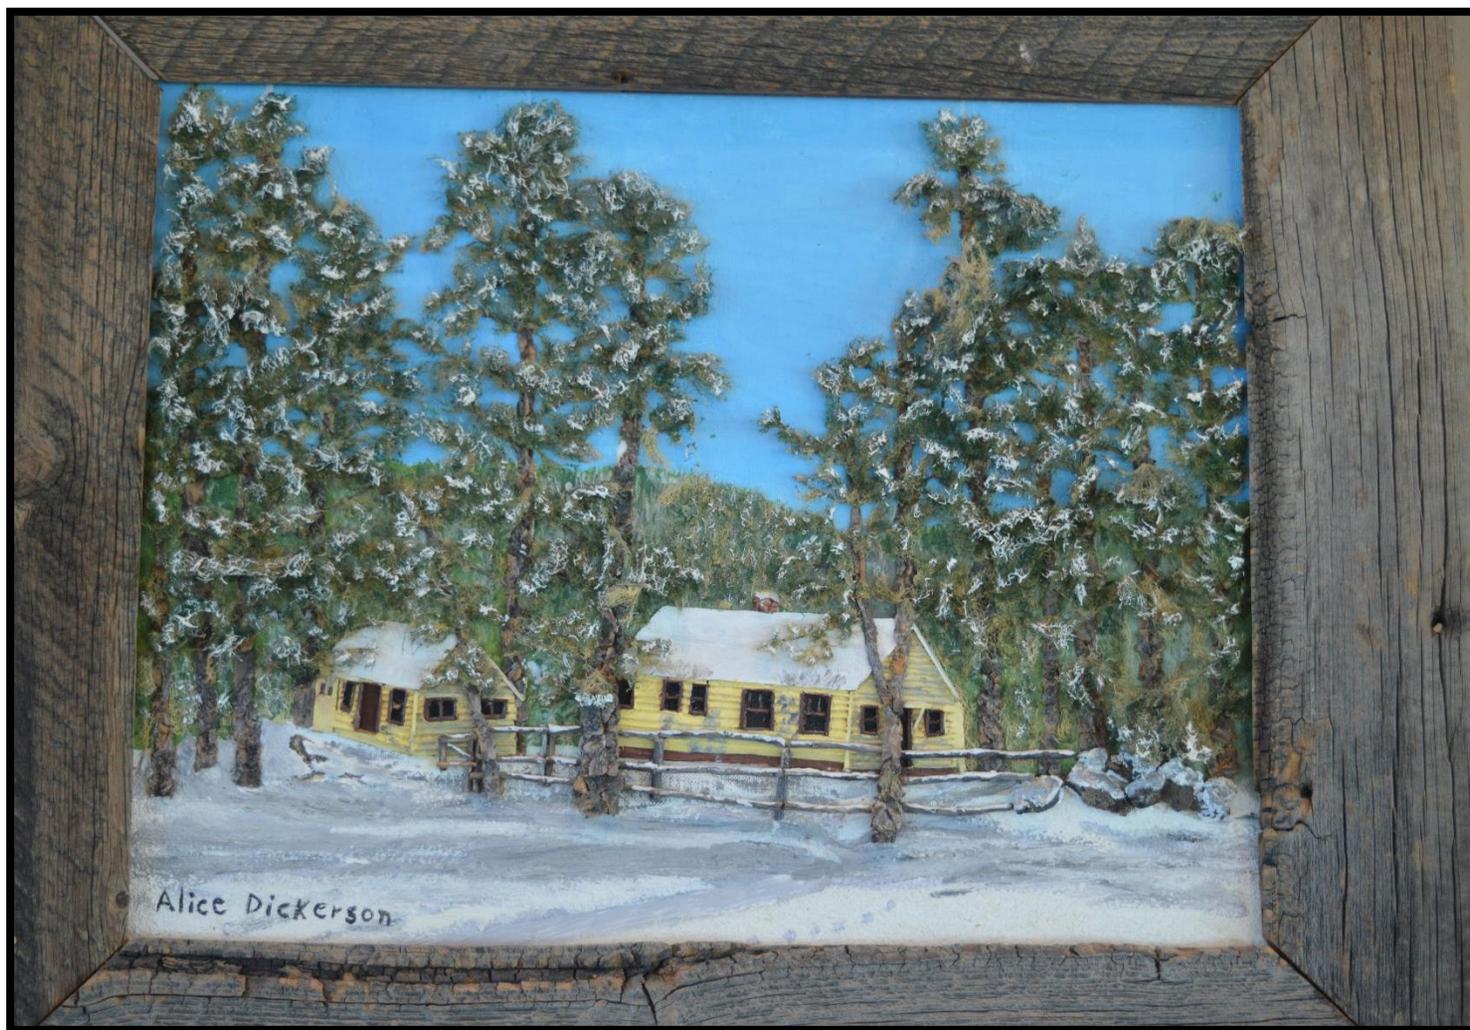
Figure 5m. Alice Dickerson Painting of the Buckhorn Ranger Station. Circa 1930s. The Main Ranger Dwelling and the Assistant Ranger Dwelling in painting. The Assistant Ranger Dwelling has since been moved within the site to the south. Alice historically lived in the Buckhorn Canyon with her family.

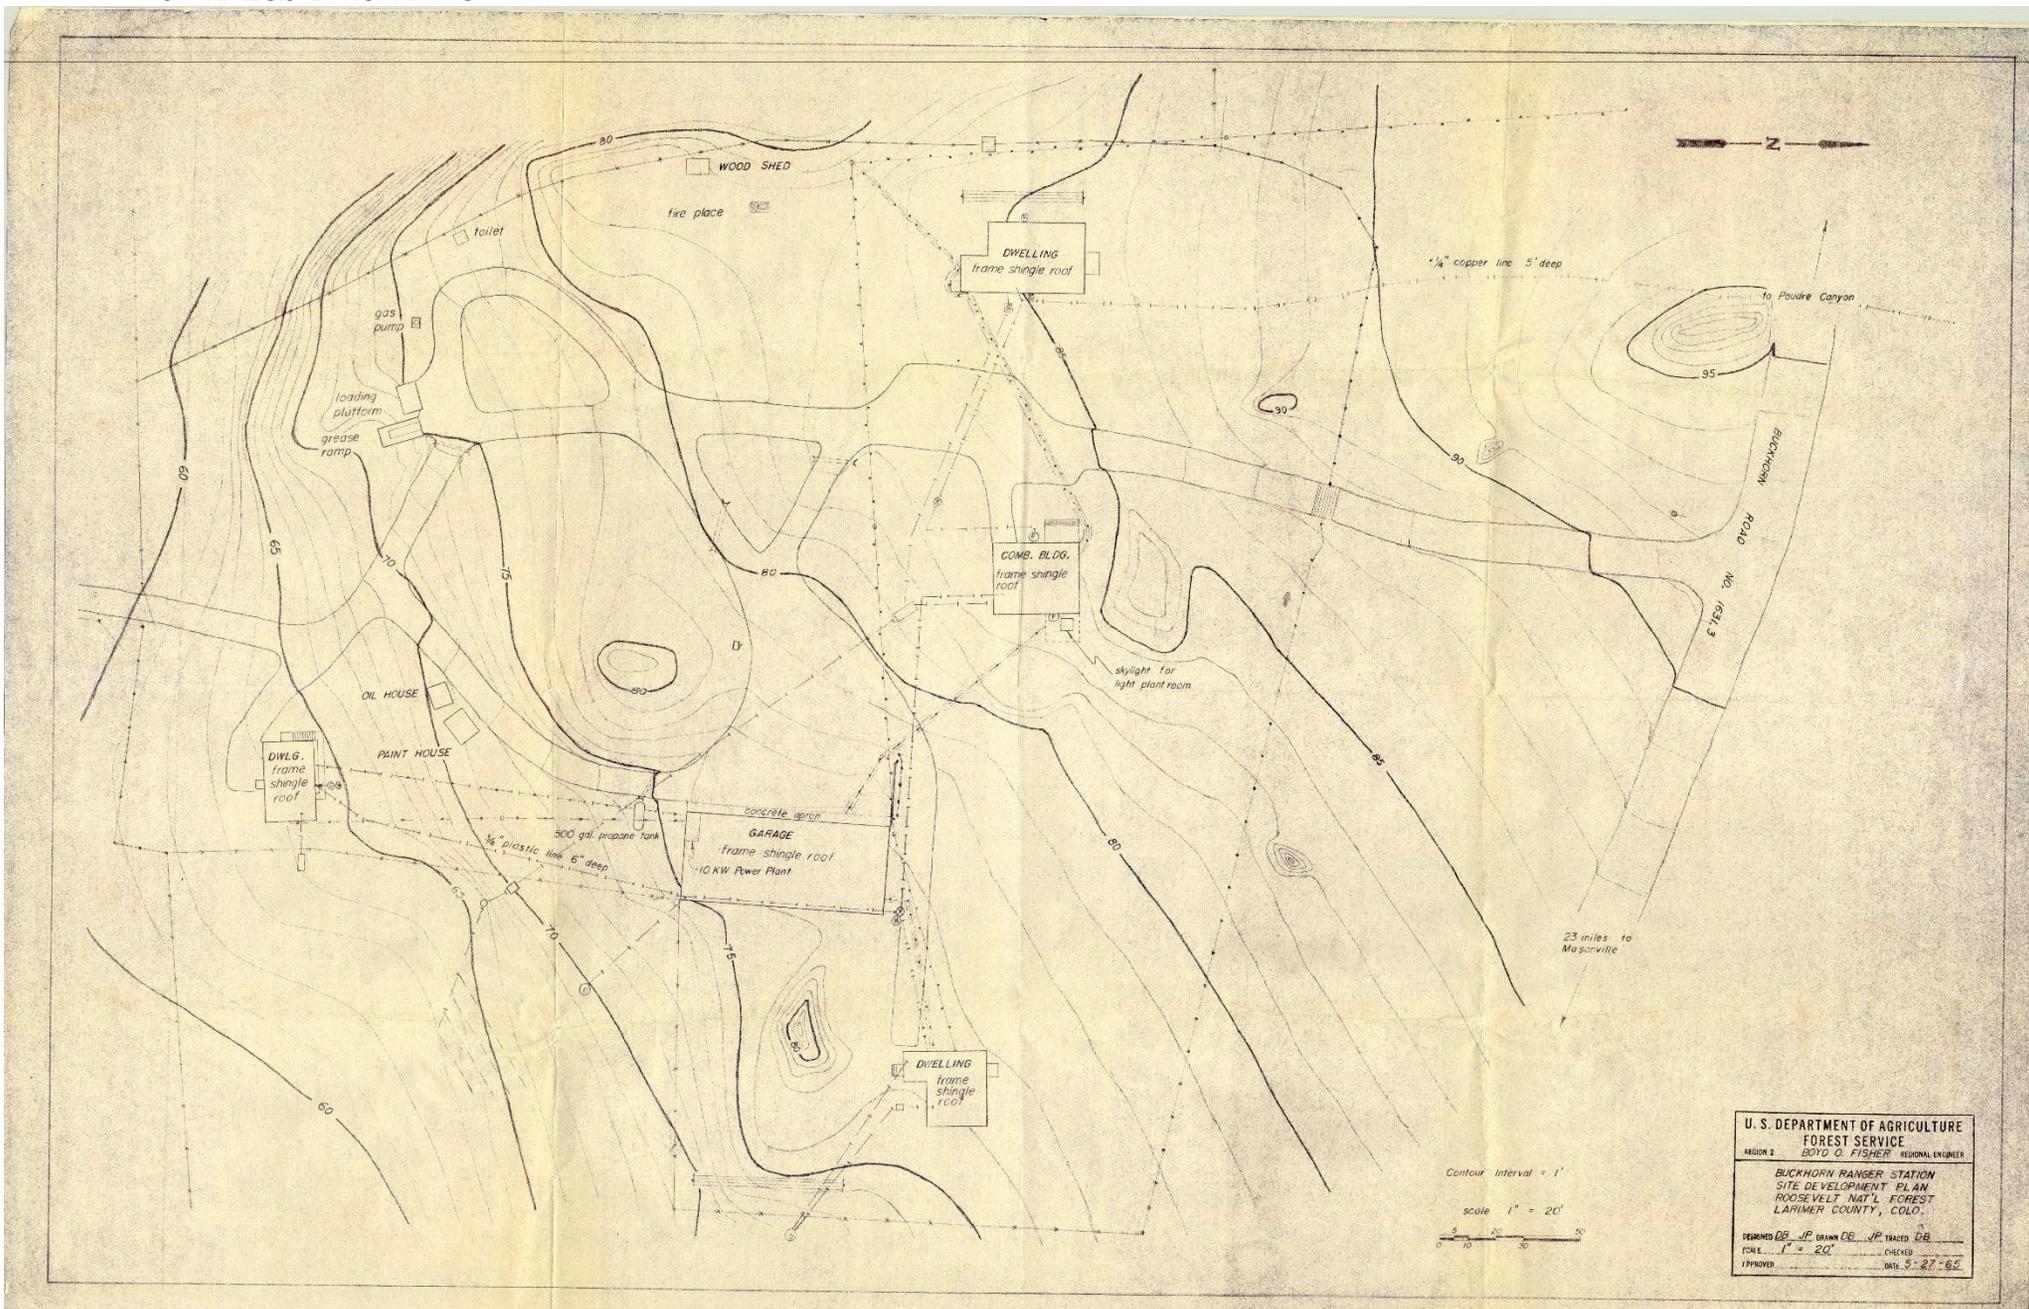
Figure 6m. "Buckhorn Ranger Station Site Development Plan" 5/27/1965.

A metal "T" clothesline is located approximately 8' west of the Ranger Dwelling. The clothesline runs most of the length of the building and can be seen on the 1965 map of the site (Plans and Maps Figure 9). A 1938 map of the site shows a longer planned clothesline (Plans and Maps Figure 2). The current clothesline posts are metal and were likely replaced during the 1980s.
