## COLORADO STATE REGISTER OF HISTORIC PROPERTIES NOMINATION FORM

Historic Name: Buckhorn Ranger Station Historic District

Other Names: Buckhorn Work Center, Old Buckhorn Ranger Station, 5LR.1862, 5LR.732

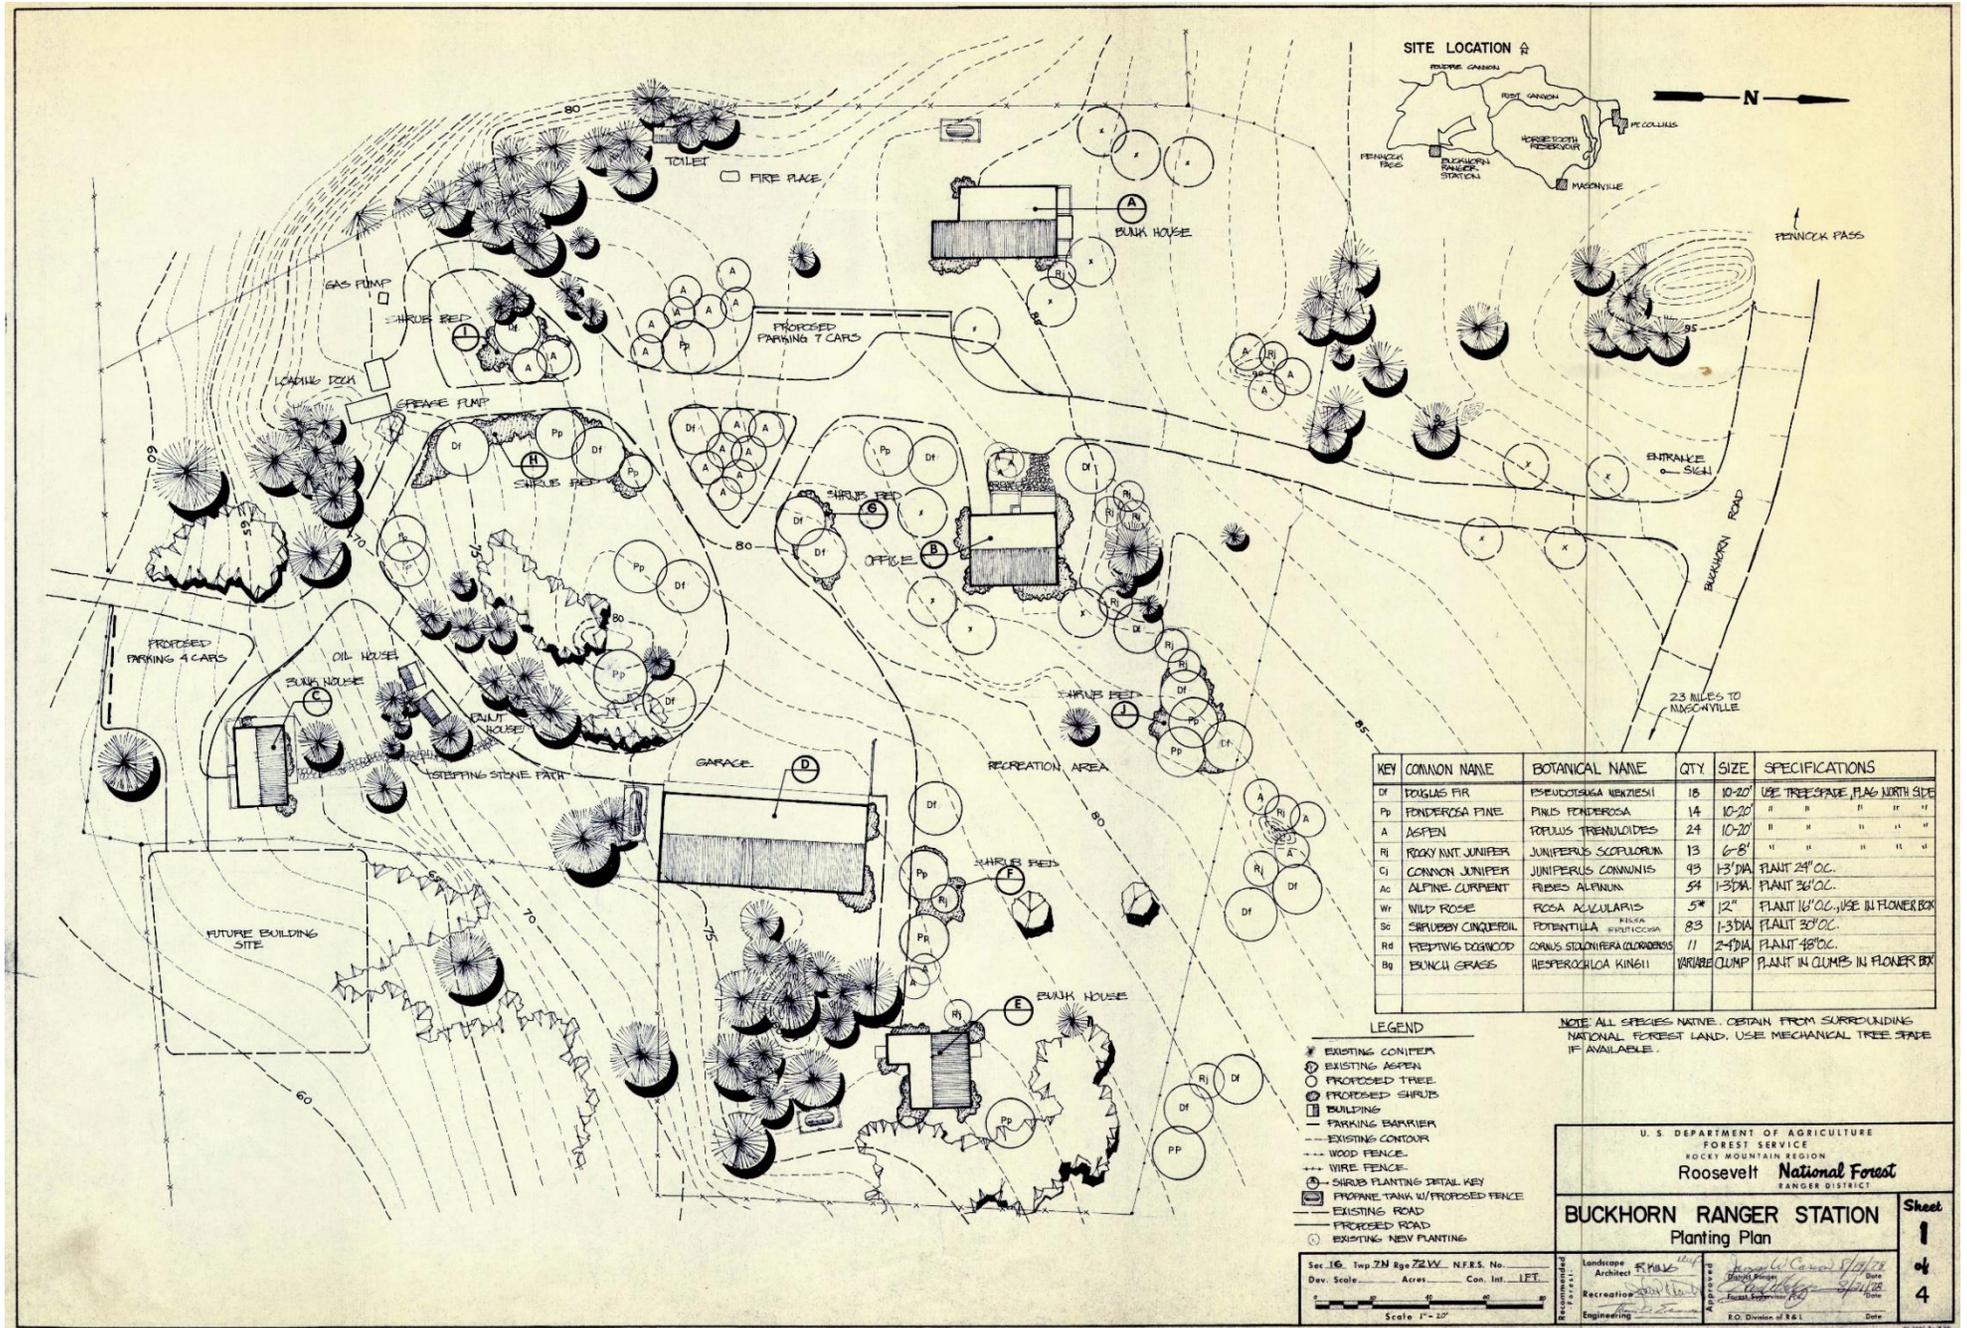
Figure 7m. United States Forest Service (1978) Development Plan of the existing site and plans for additional plantings, ground features and parking areas. These plans did not come into fruition.

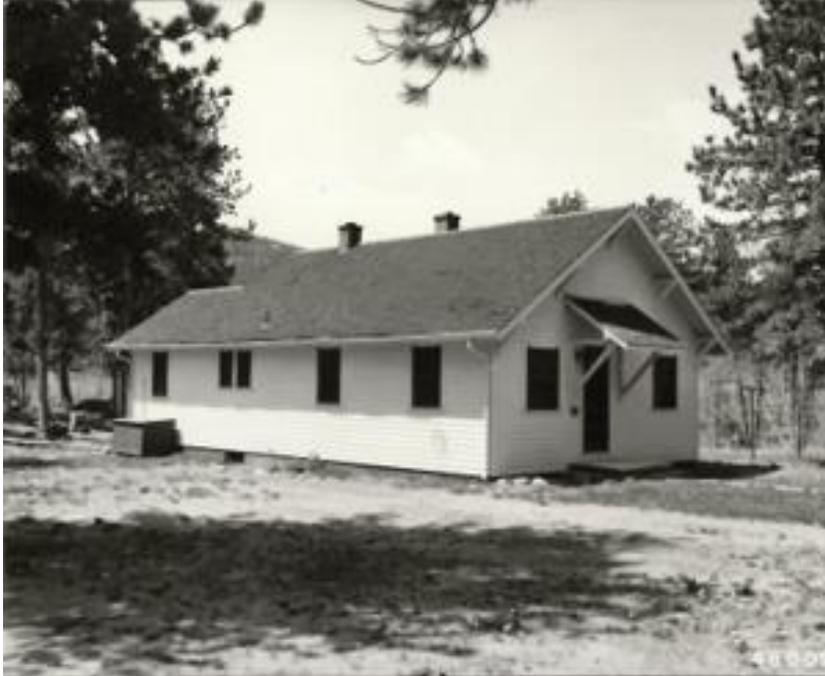
Figure 1h. The main dwelling in 1950. Fence has since been torn down.  
Photo by E.H. Mason 6/6/1950.

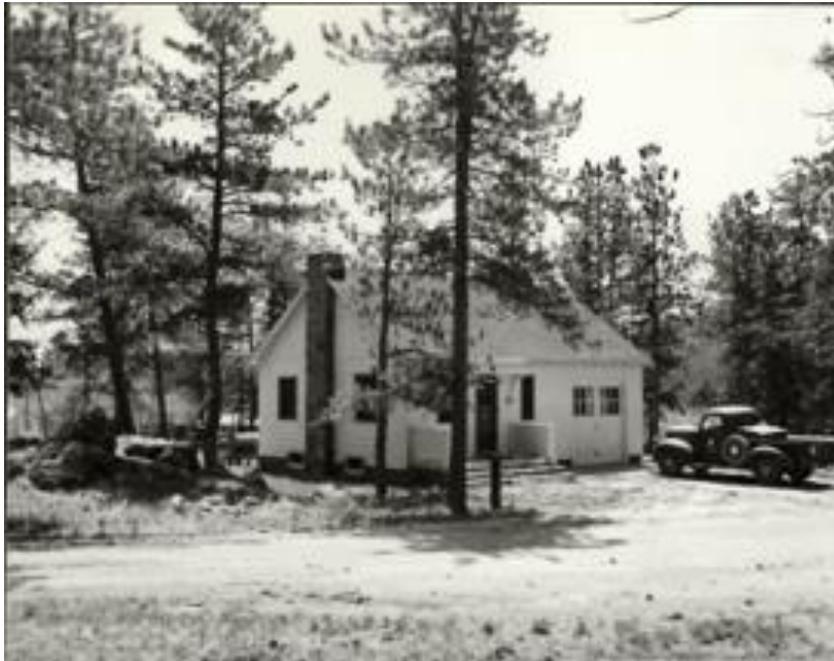
Figure 2h. The new office-garage converted from a dwelling. Photo by E.H. Mason on 6/6/1950. New Fire Guard-GDA dwelling in far-left background which was converted from the old office.

As previously noted, the first office for the ranger station (A502) was built in 1933. That building was then moved 300' to the east in 1949-1950 after this new office building (A504), also known as the "combination office building," was underway. By 1940, the new office building was completed.

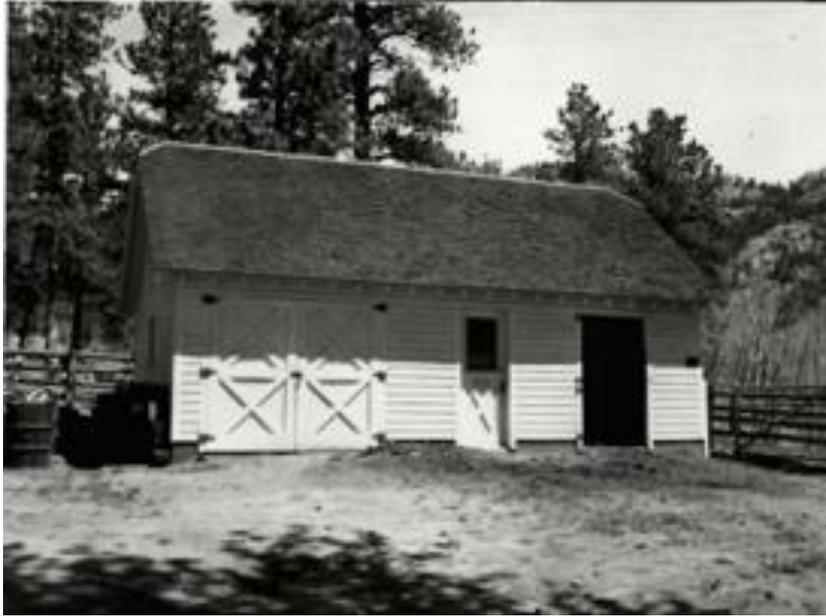
Figure 3h. The horse-barn on 6/6/1950. Photo by E.H. Mason.  
This building was converted in 1962 to become a bunkhouse.

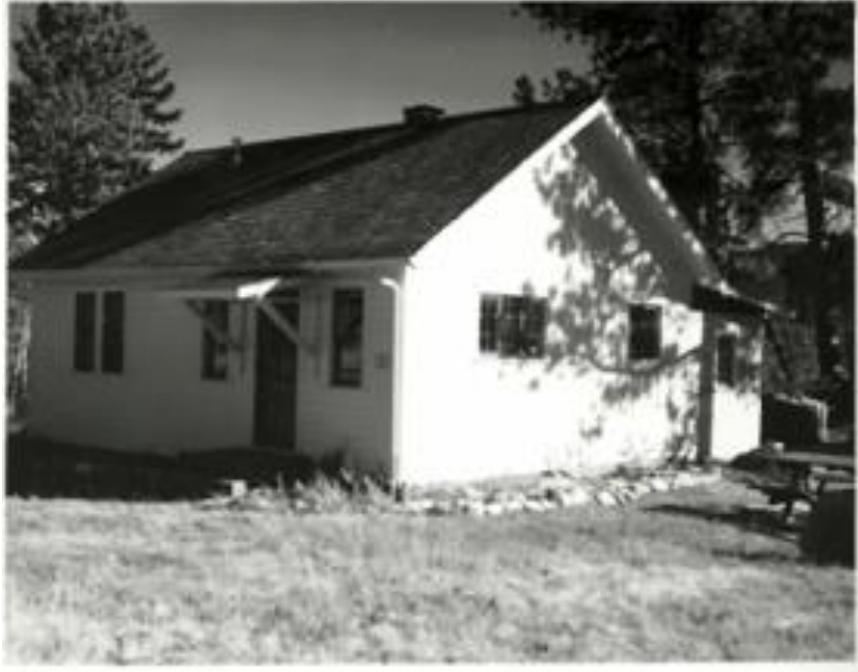
Figure 5h. The new back-porch on the GDA dwelling as it appeared in Sept of 1961.  
Photo by W.A. Parsons.

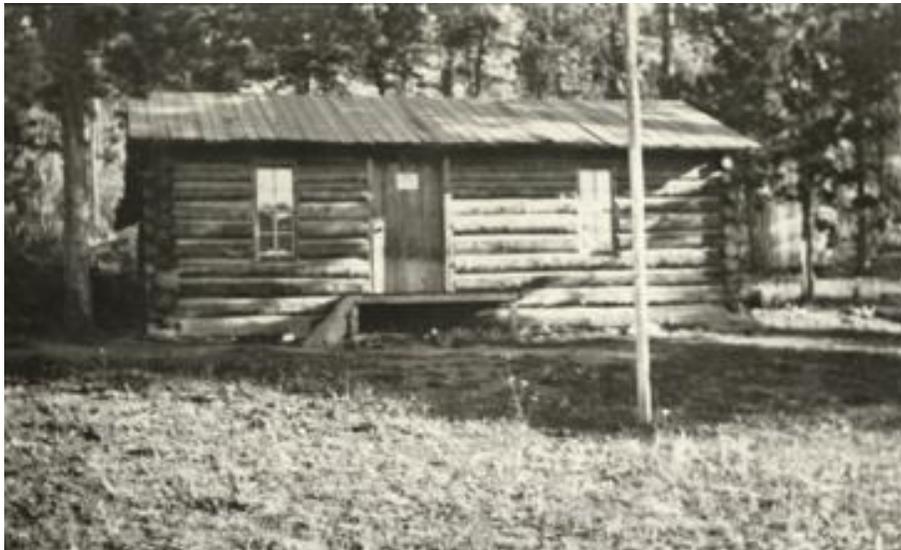
Figure 6h. The original ranger station. Built between 1906 and 1907. Occupied first by Joe Ryan. Location is across the CR 44H Buckhorn Road north of the present site.

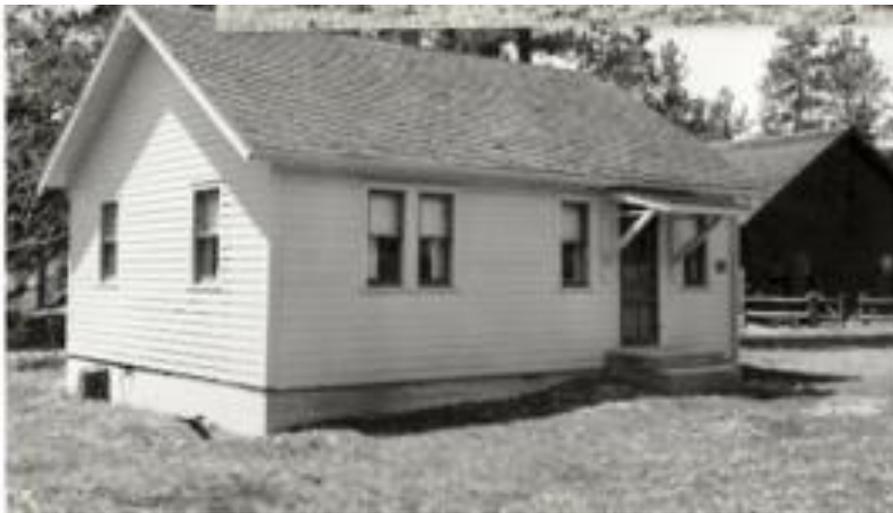
Figure 10h. Assistant Ranger's Dwelling now occupied by General District Assistant since the early-1950s. This building was the old office in the above photos. It was moved in 1949-1950 and remodeled as a house. Photo taken in 1936 by E.H. Mason.

moved in 1949-50, the garage was removed, and two double hung windows attached with a center rail were added in the location of the garage door. The building has a concrete foundation with a crawl space and no basement. The shed-roof rear porch addition was added in 1961. The addition is sympathetic to the original 1933 design and 1950 modifications and was planned in 1941. The assistant ranger's dwelling is now used to house seasonal employees.

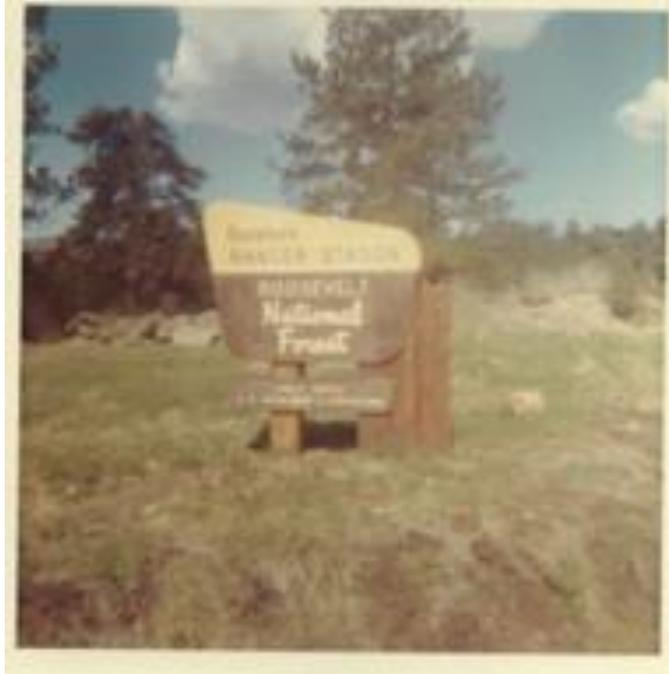
Figure 11h. New sign installed about 1968.  
Photo taken by W.A. Parsons in July of 1969.

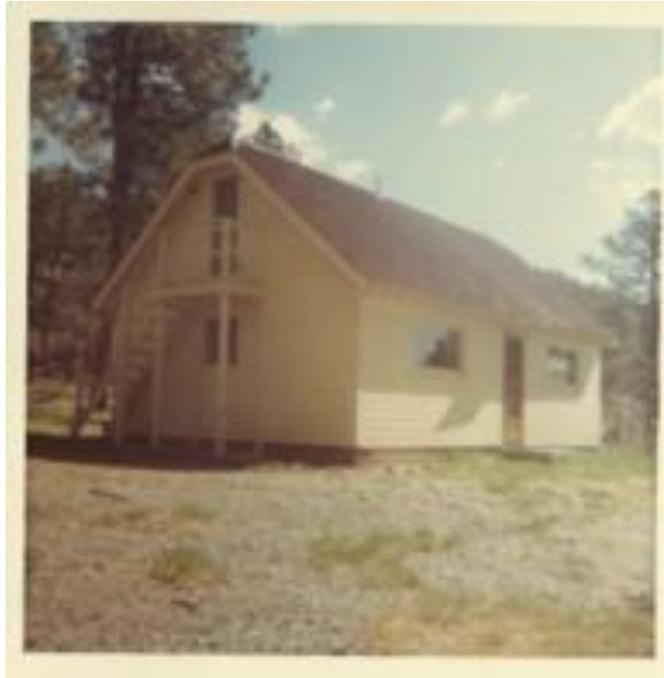
Figure 13h. The horse barn was converted into a bunkhouse in 1962 by the assistant ranger Charles E. Williams. Photo taken in 1969 by W.A. Parsons.

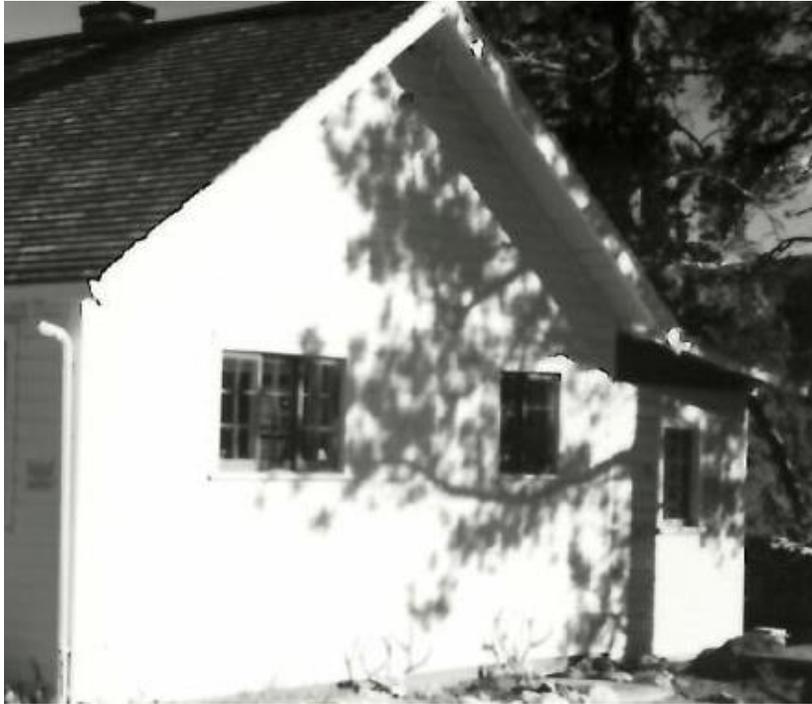
Figure 15h. 1933 Photo of Office before move and remodel (1949-50) and porch addition (1961). Note different window on left (east side) of north elevation and smaller window on right (west side) of north elevation compared to modern photos.

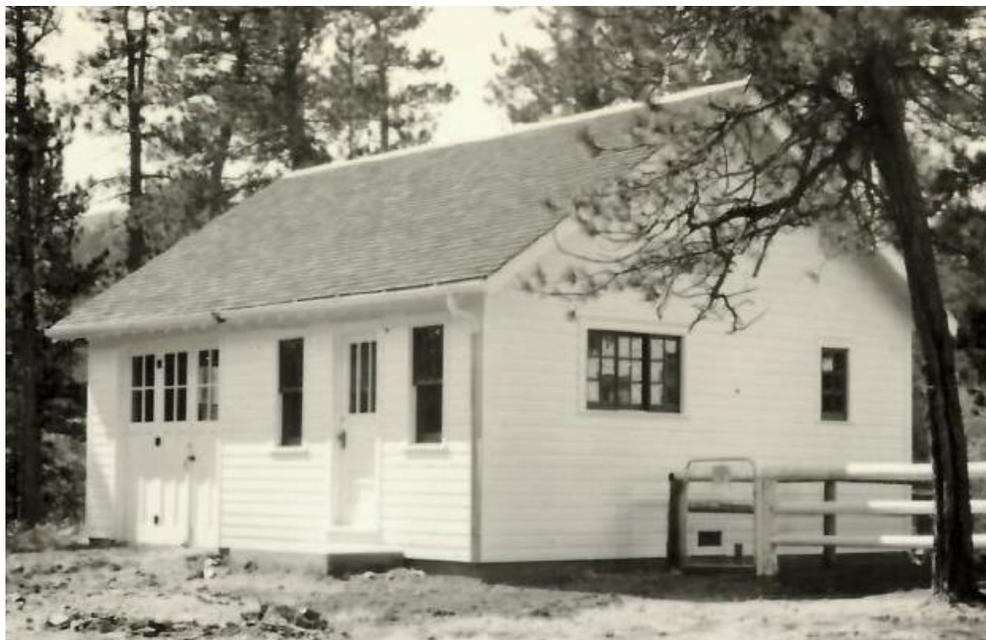
Figure 16h. Buckhorn office and garage. Built in summer of 1933 by the CCC.  
Photo taken on 9/29/1933 by C.L. Van Giesen.
