# National Register of Historic Places Registration Form

historic name Baca Land Grant No. 4 / Baca Ranch Rural Historic Landscape

Baca Ranch Rural Historic Landscape  
Name of Property

Saguache County, Colorado  
County and State

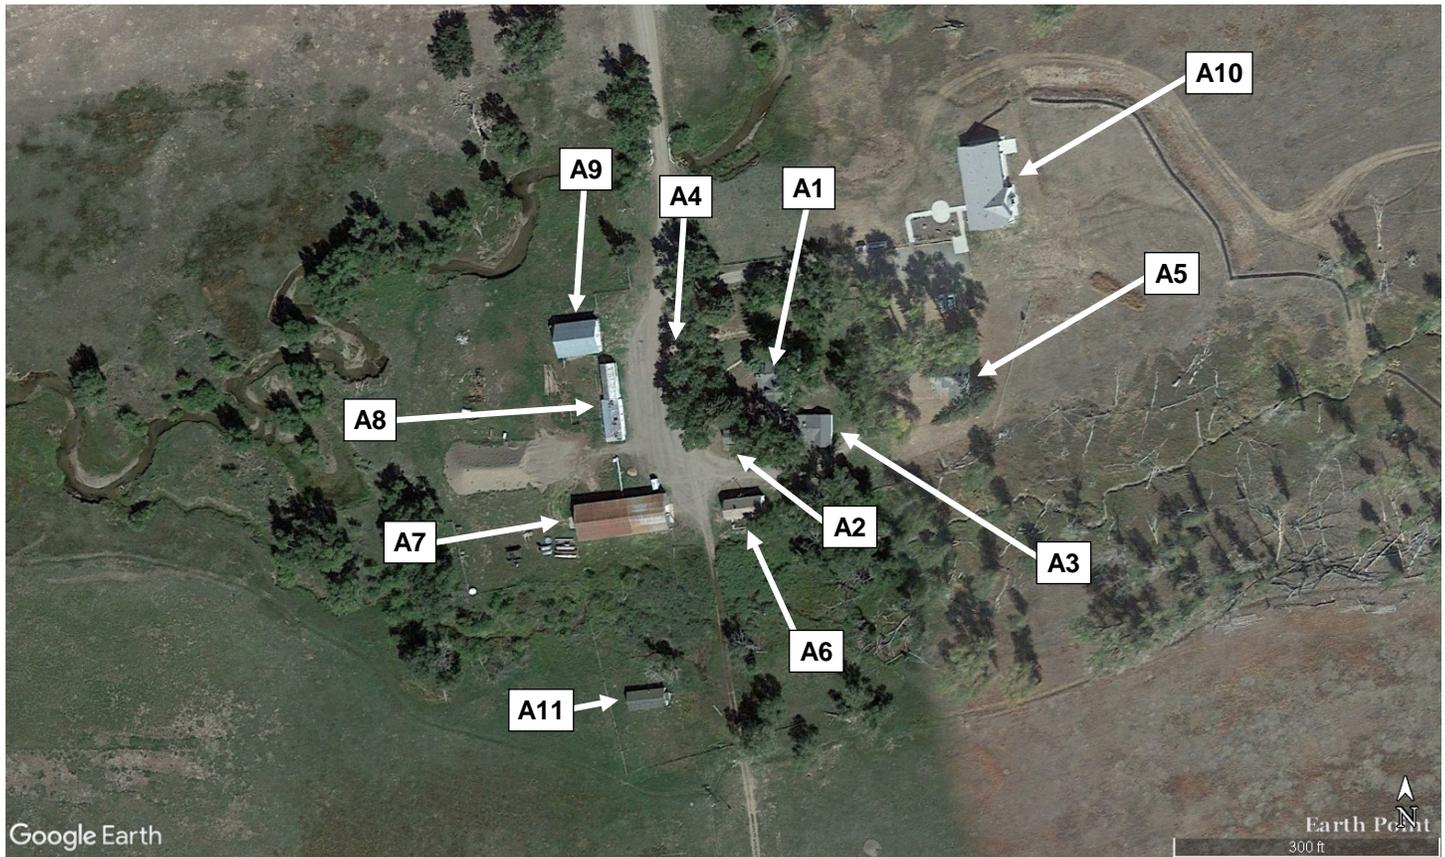
Map 5: Home Ranch – Headquarters Area

A1	Main House
A2	Bunkhouse/Office
A3	Bunkhouse/Garage
A4	Pump House
A5	Foreman's House
A6	Feed and Seed Storage Building
A7	Butler Building
A8	Equipment Garage and Tack Barn
A9	Barn
A10	USFW Headquarters
A11	South House

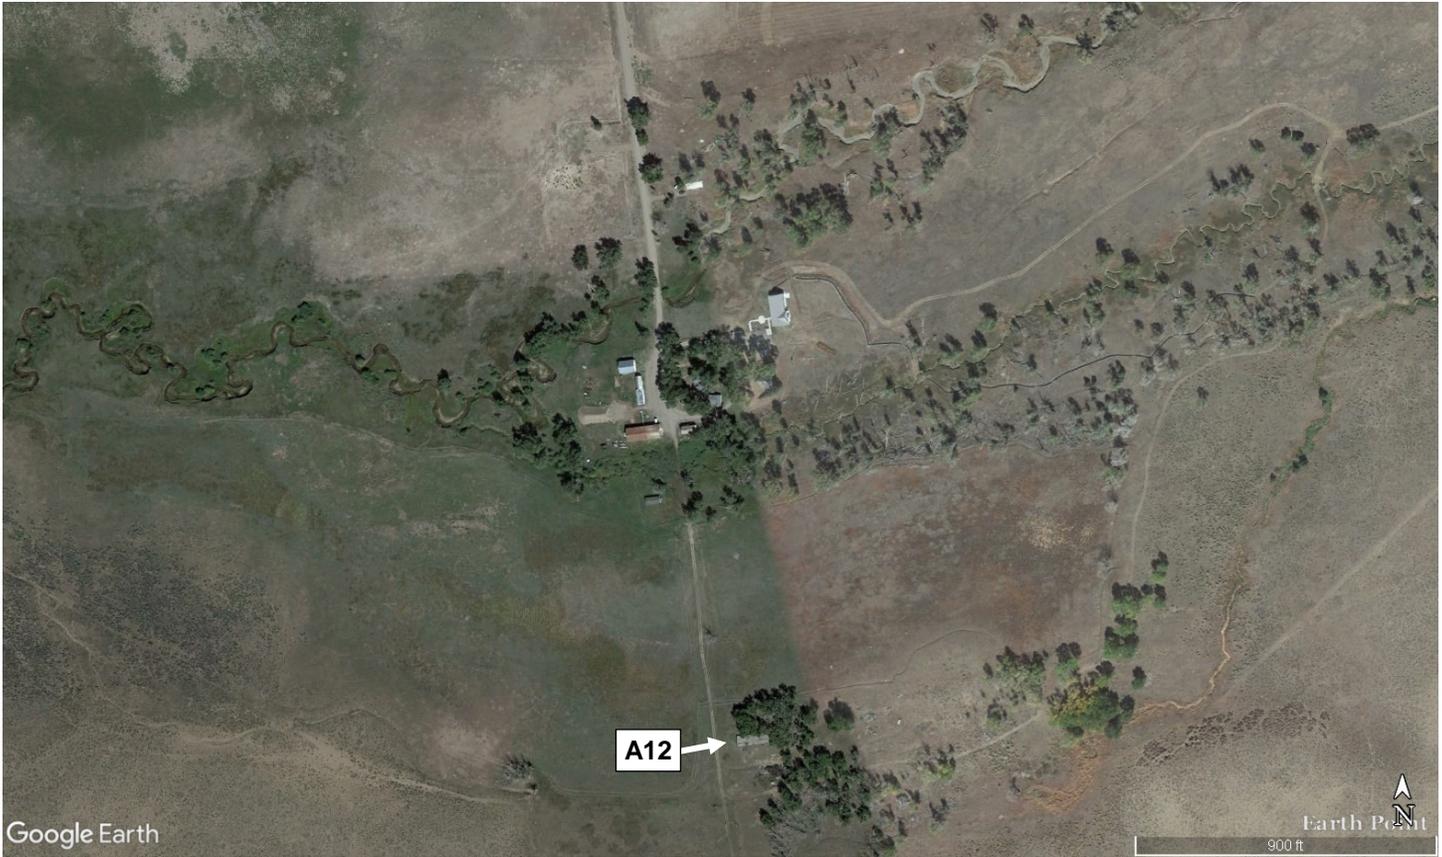
Map 6: Home Ranch – Lambing Shed

A12	Lambing Shed
-----	--------------

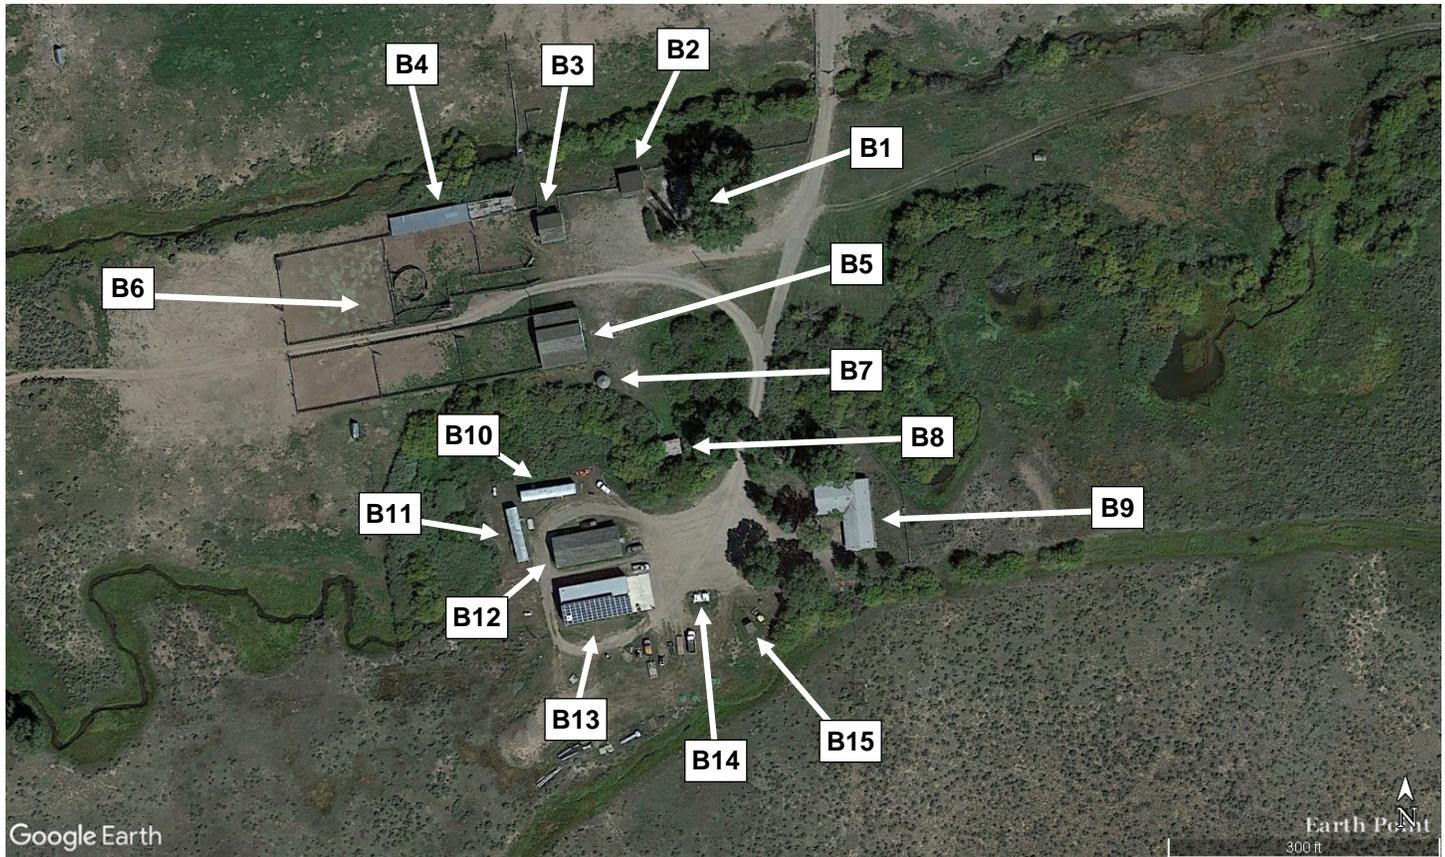
Map 7: Pure Bred Place.

B1	House #1
B2	Garage
B3	Horse Barn
B4	Barn/Loafing Shed
B5	Auction Barn
B6	Corrals and Cattle Chutes
B7	Grain Bin
B8	Meat Storage Shed
B9	House #2
B10	Trailer #1
B11	Trailer #2
B12	Pigeon Coop/Barn/Storage Building
B13	Metal Building
B14	Pump House
B15	Gas Pumps

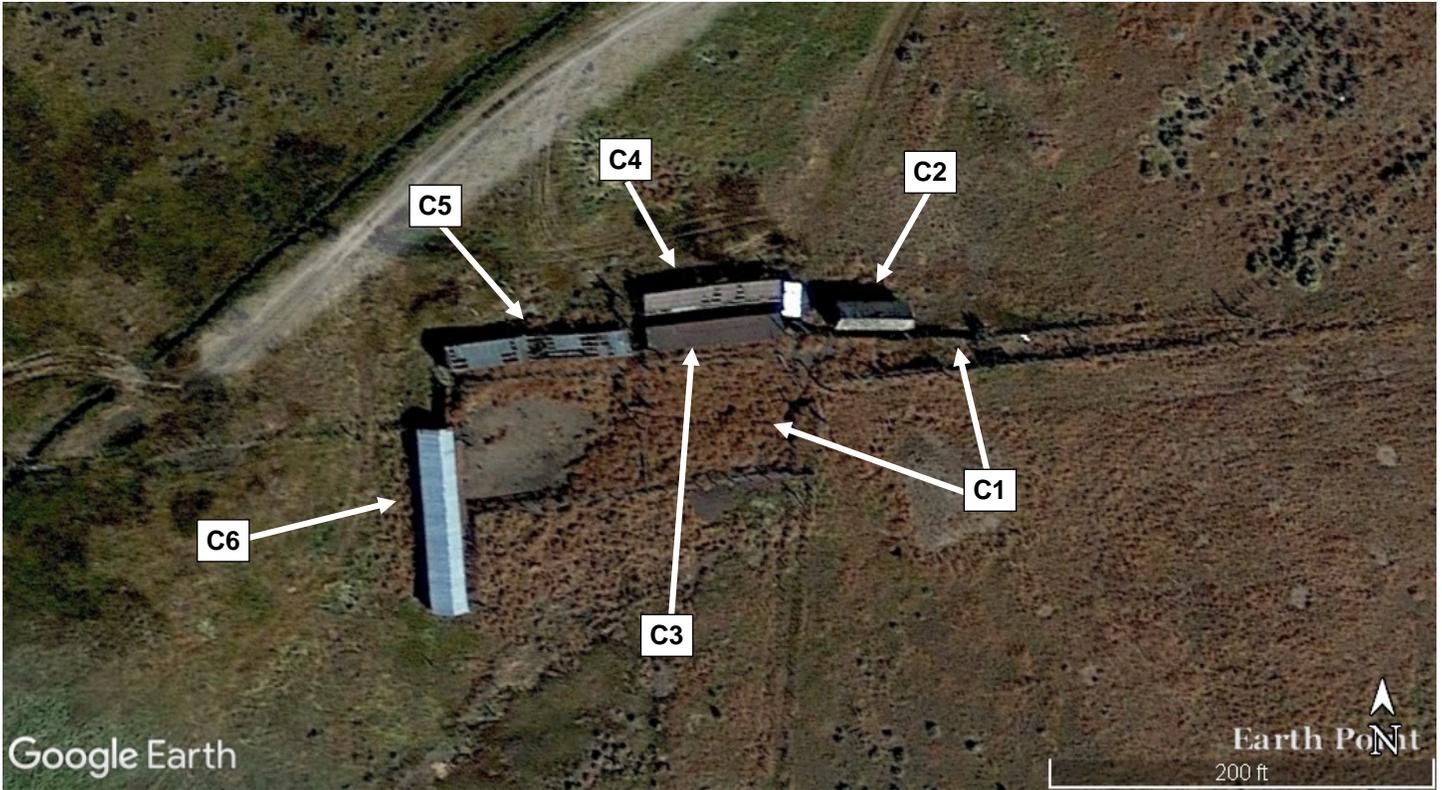
Map 8: Calving Camp.

C1	Corral Complex
C2	Shotgun House
C3	Calving Shed #1
C4	Loafing Shed
C5	Calving Shed #2
C6	Calving Shed #3

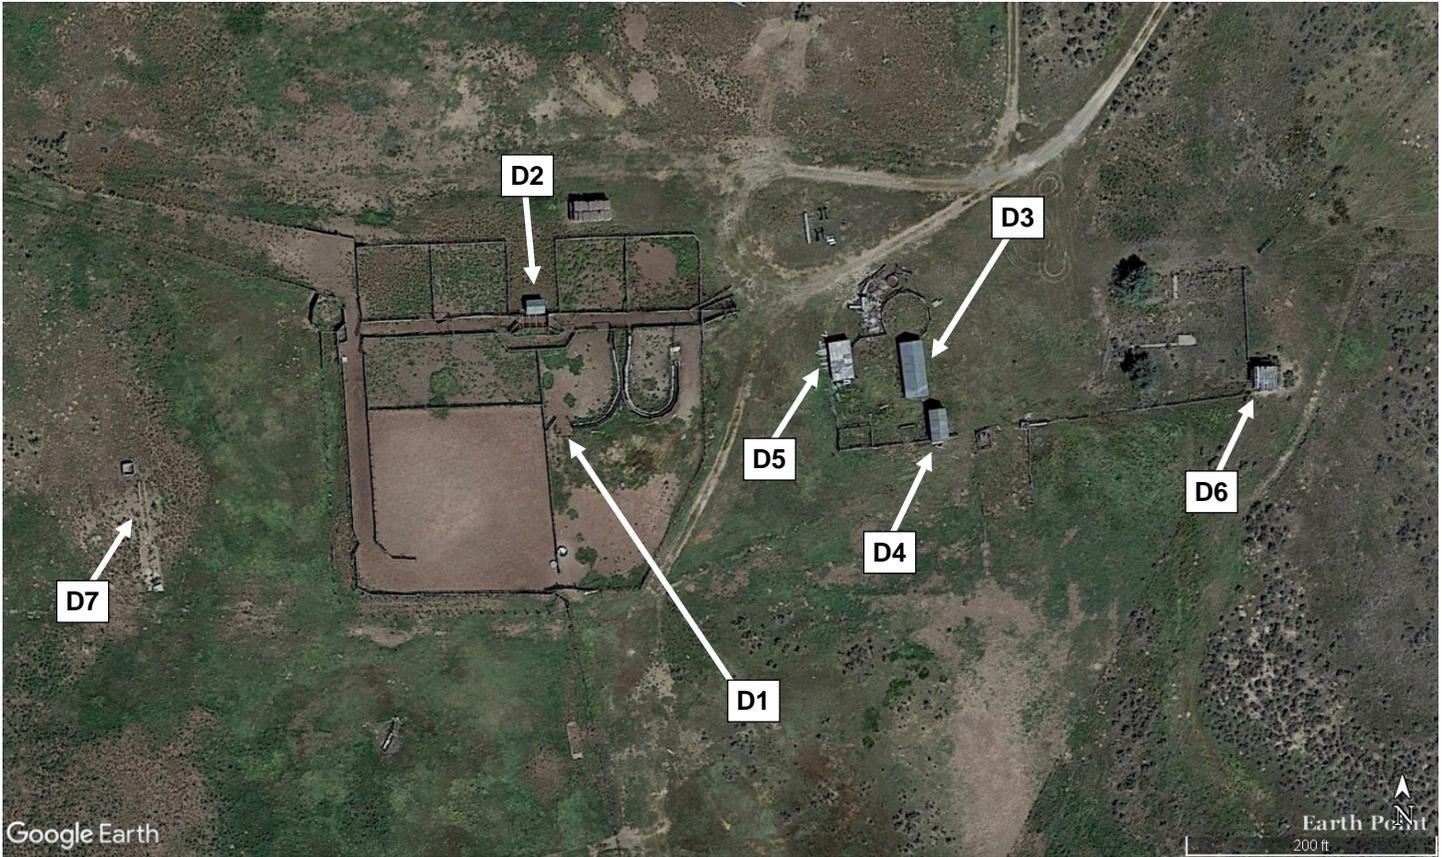
Map 9: Sheds Camp-Shipping Corrals.

D-1	Corral Complex
D-2	Scale House
D-3	Barn
D-4	Equipment Shed
D-5	Loafing Shed
D-6	Baca Grande Airport Terminal
D-7	Cattle Dipping Vat

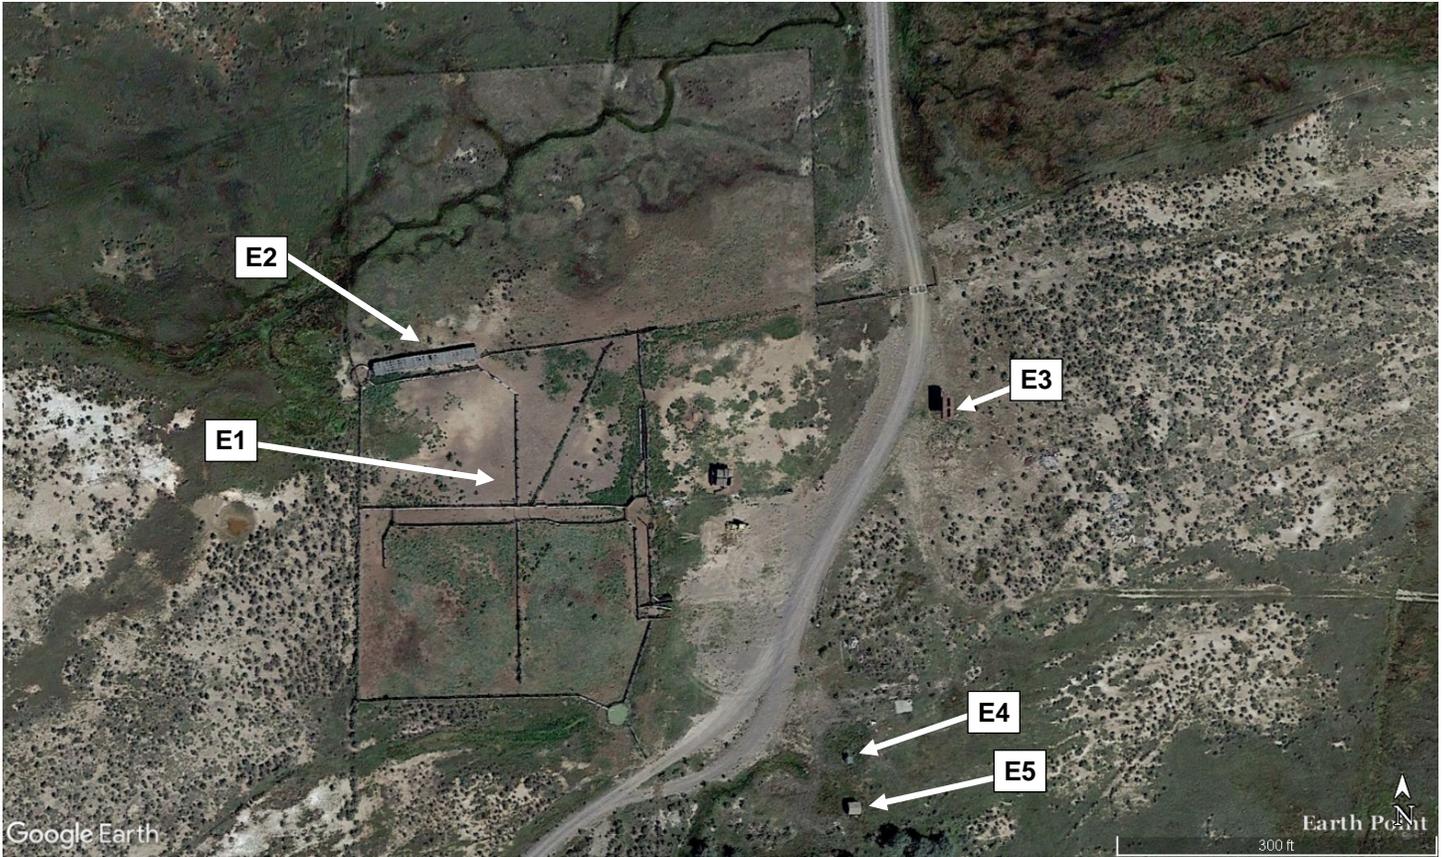
Map 10: Willow Camp.

E-1	Corral Complex
E-2	Loafing Shed
E-3	Feed Storage Bin
E-4	Tank House
E-5	Shed

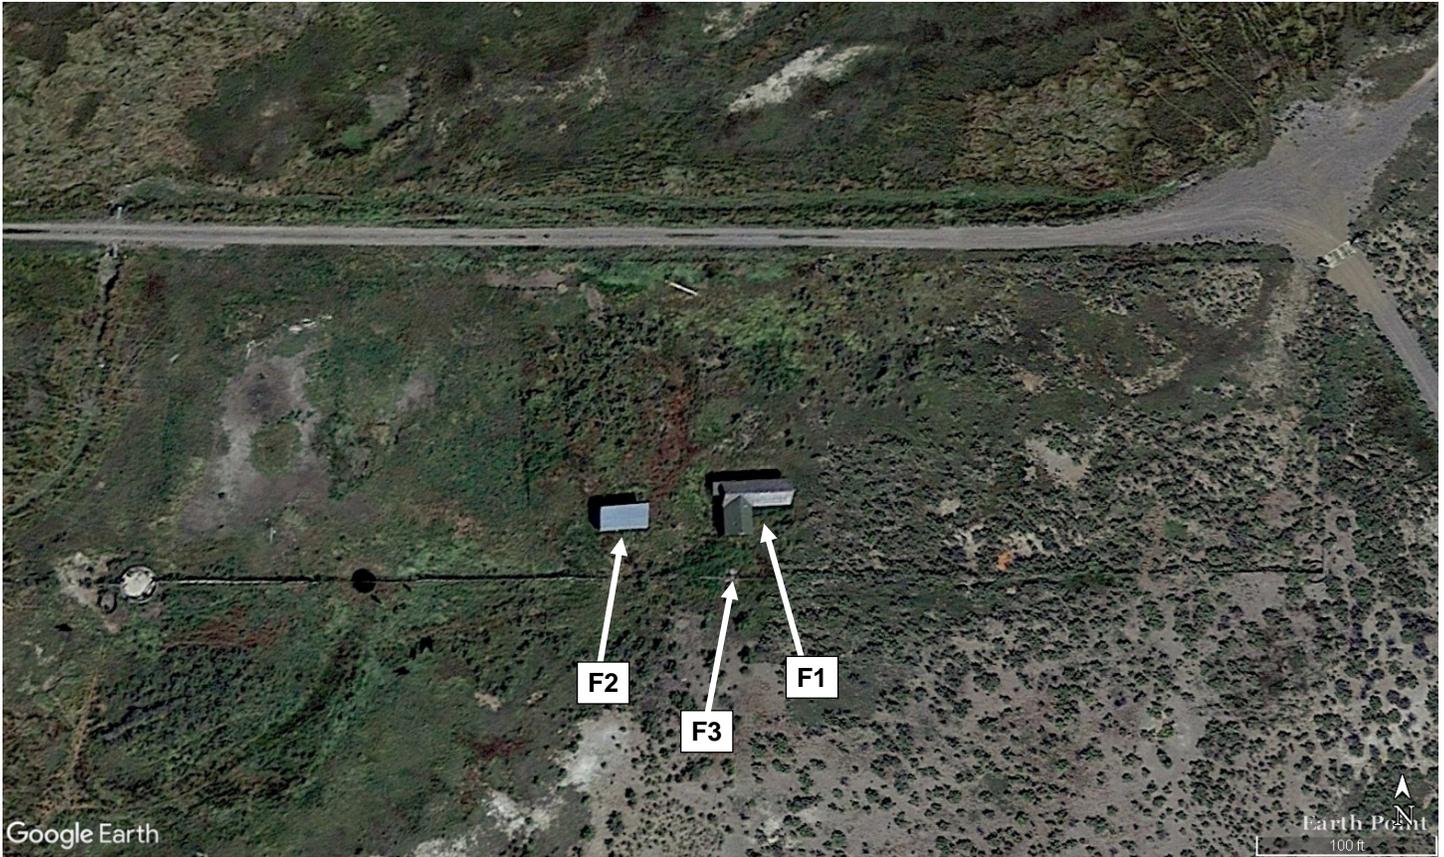
Map 11: Cottonwood Camp.

F-1	House
F-2	Outbuilding
F-3	Cistern

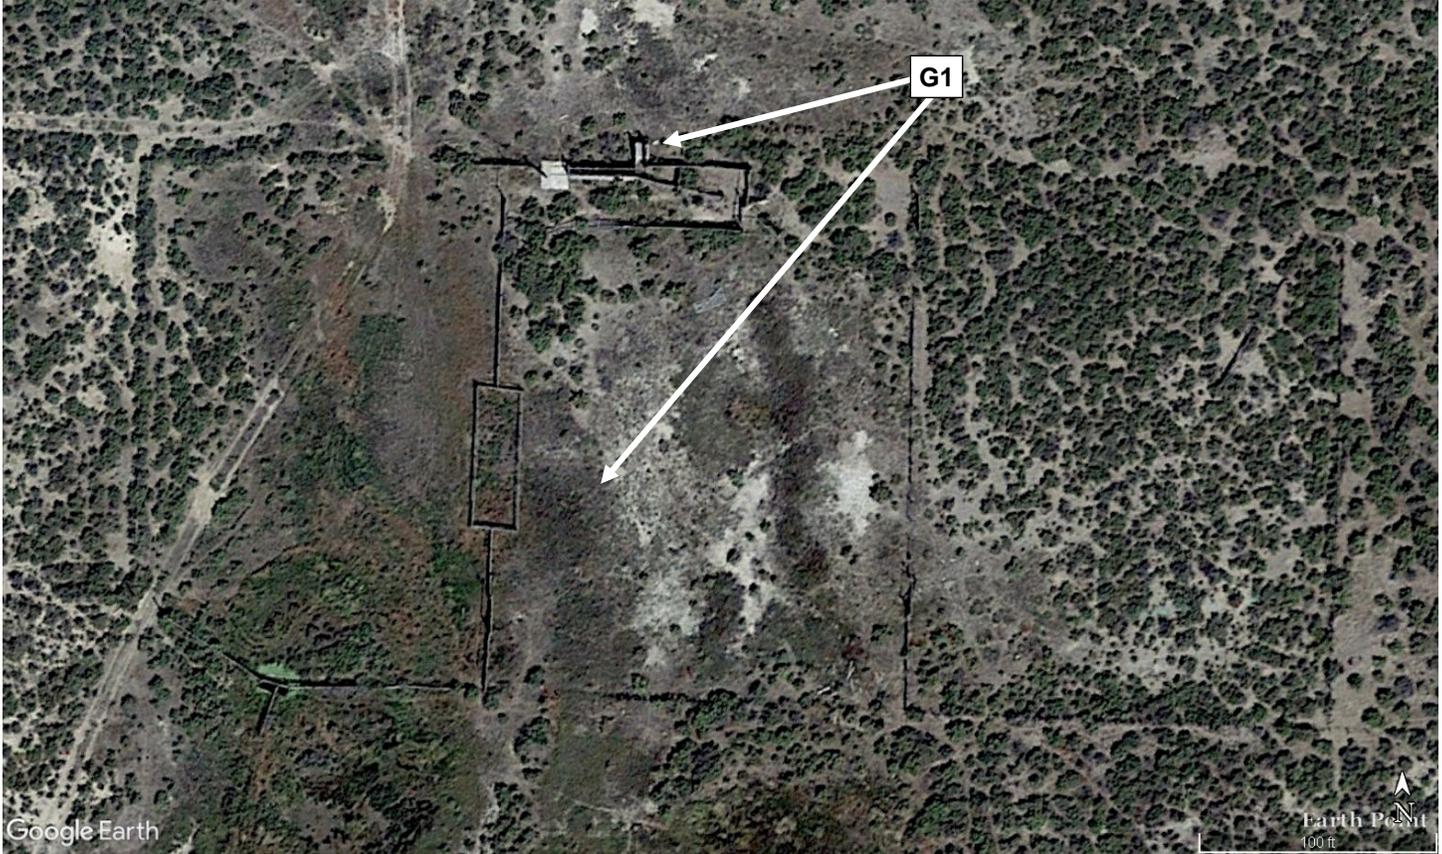
Map 12: Deadman Camp.

G-1	Corrals and Chutes
-----	--------------------

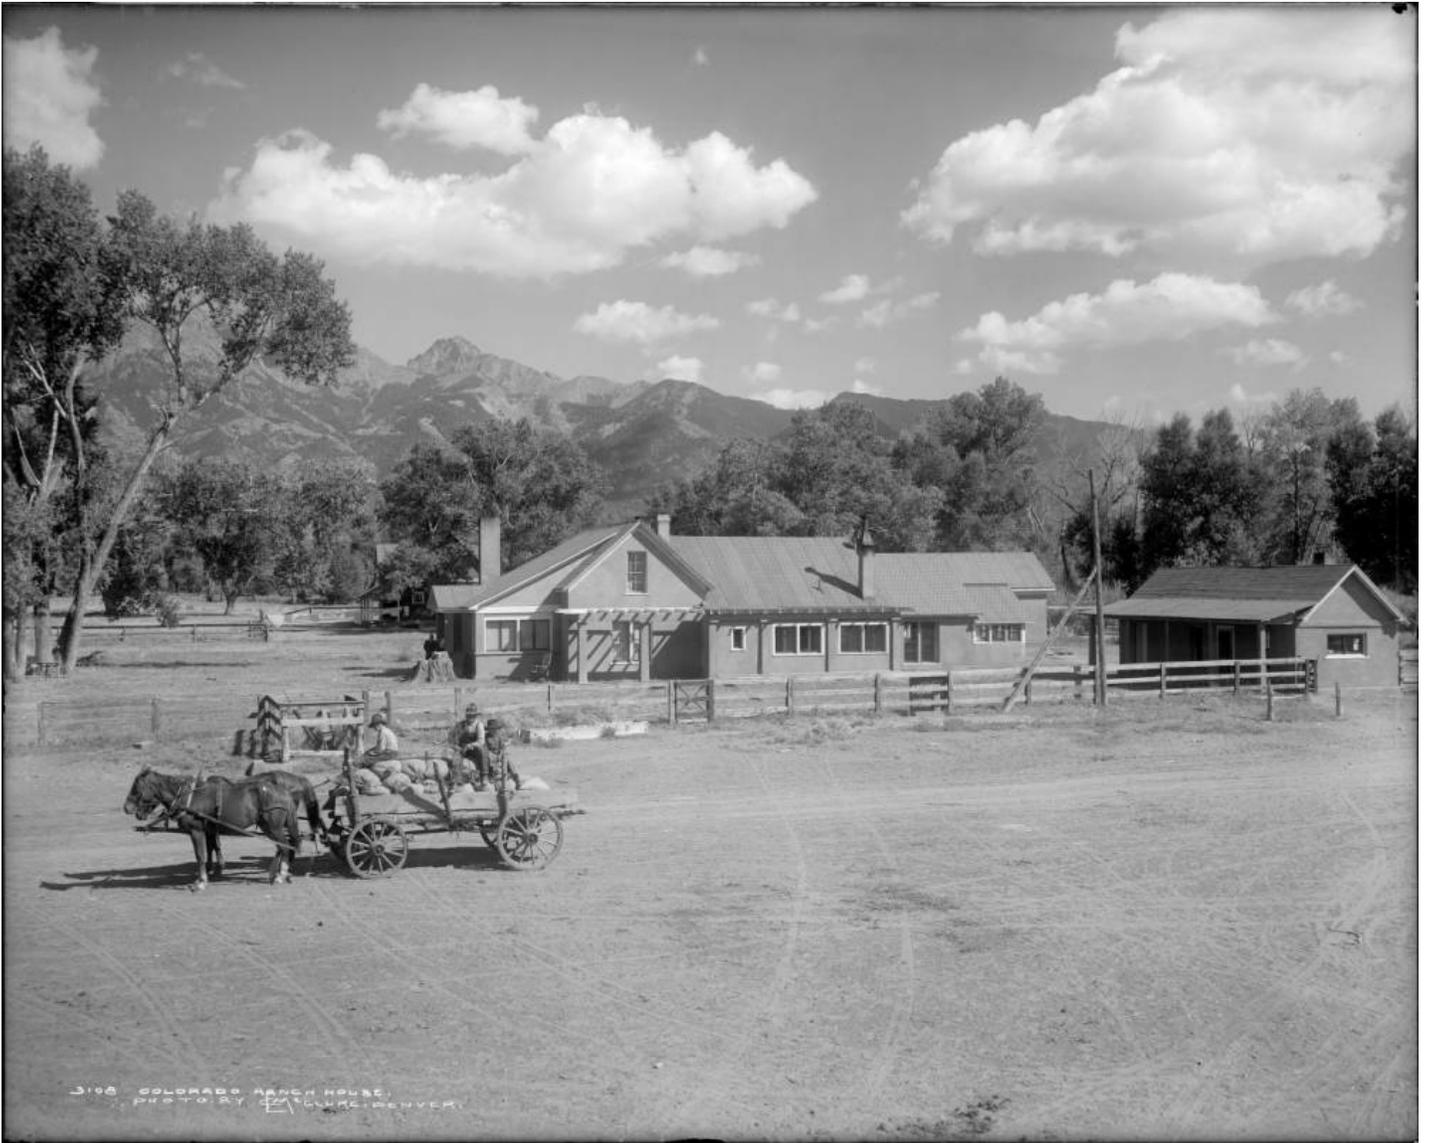
Figure 7: A ca. 1920-30 photograph of the Home Ranch documents the Main House, Bunkhouse/Office, and Bunkhouse/Garage. The Foreman's House is visible in the background. (Denver Public Library Special Collections, MCC-4154)

Constructed ca. 1881, the 36' x 14', one-story, rectangular-plan, adobe Office/Bunkhouse stands facing north directly south and west of the Main House. The side-gable composition shingle roof has exposed rafter tails and a large exterior brick chimney clad with stucco rises on the building's south side. The adobe walls are clad with stucco and a full-width shed-roof porch with concrete floor stretches along the building's north (front) side. The porch roof has exposed rafter tails and is supported by tapered square piers clad with stucco. The north (front) side is asymmetrical in design and features two entrances—a primary entry marked by a two-light paneled wood door flanked by two-over-two wood windows and a secondary five-panel wood door to the east. All doors and windows are historic, including the one-by-one wood slider window and single light wood windows on the west and south sides, and the wood panel door at the rear (south) entrance. A flat decorative plaque in the shape of a steer's head sits near the top of the west wall. Inside the building, "LUIS MARIA BACA GRANT № 4 / 1823" appears in raised letters on the fireplace mantel. A ca. 1920s photograph of the building (see Figure 7) documents the porch, confirming that the building's existing form was essentially complete by that time.

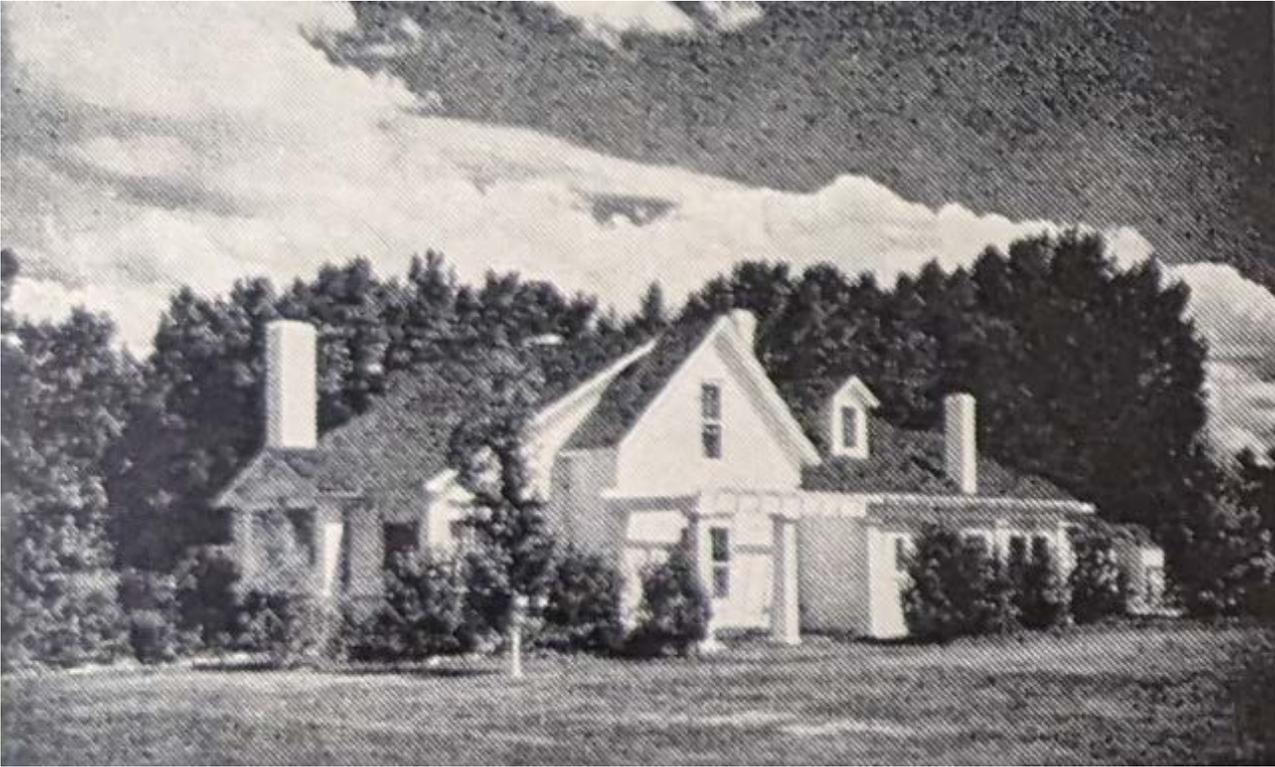
Figure 8: Main House at the Home Ranch, ca 1945. Note presence of dormers. Main House entry not yet enclosed. (Reprinted from Bassford, *They Call It Baca Grant*, 1945).

The Main House, built ca. 1881 and remodeled multiple times over the years, stands facing north at the south edge of the grass lawn within the circular gravel drive. The 80' x 37' irregular-plan building appears to have begun as a one-and-one-half-story, rectangular plan, side-gable adobe residence, later expanded by a shed-roof addition to the north (front), and a succession of gable-roof additions to the south (rear). The foundation appears to be a mix of adobe and concrete and the walls are constructed of adobe finished with stucco. The composition shingle roof has overhanging boxed eaves, and two

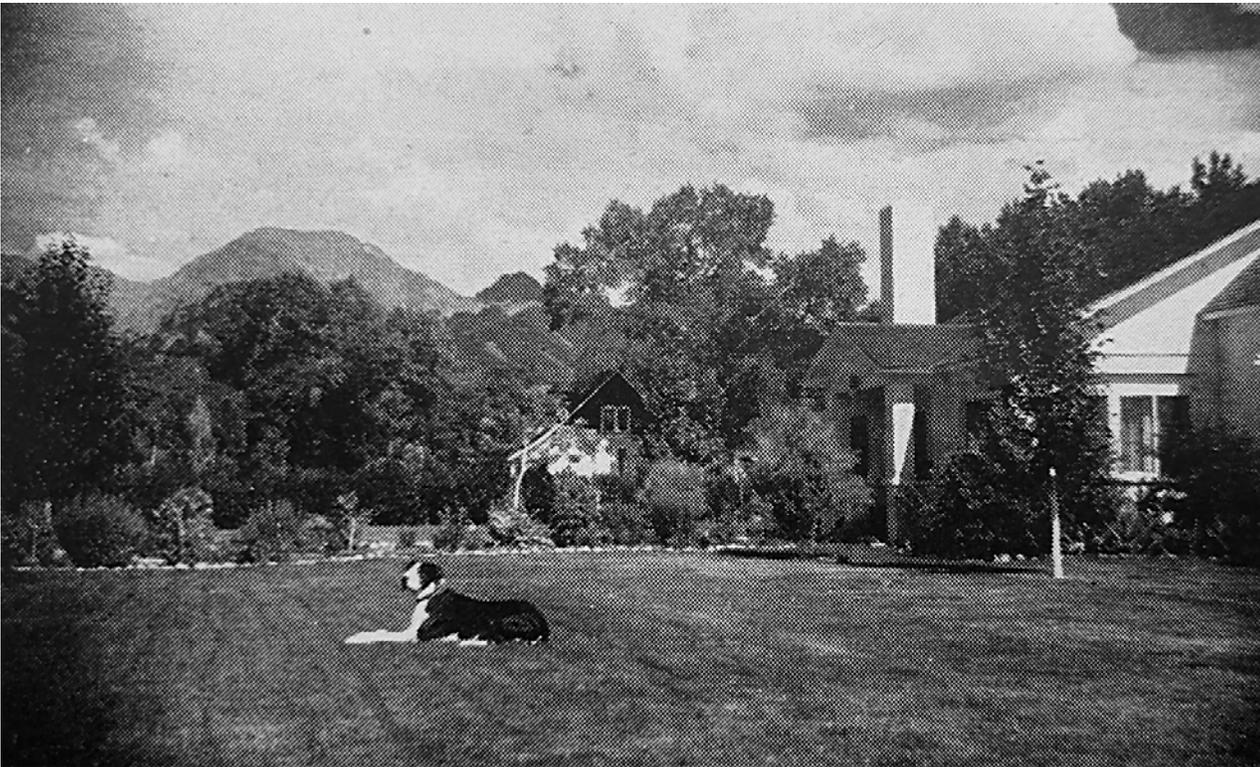
Figure 9: Home Ranch, ca. 1950. Foreman's House (left) and Main House (right). Note fenestration pattern on west wall of Foreman's House. Main House entry not yet enclosed. (Reprinted from *Baca Grant*, 1950.)

*Alterations:* Existing documentation does not indicate the exact dates of the changes, but historic photographs and existing materials suggest that significant changes occurred after 1950 and later, including alterations to the north and south dormers, window openings, and windows. In 1938, Evelyn D. Mayer described the Foreman's House as a "shingled bungalow" suggesting that the siding was replaced after 1950 as well. The metal slider windows, multi-light bronze metal windows, and side entry door were likely installed later. Due to its numerous alterations that cannot be adequately dated but appear to date after the period of significance, the building is considered non-contributing to the district.

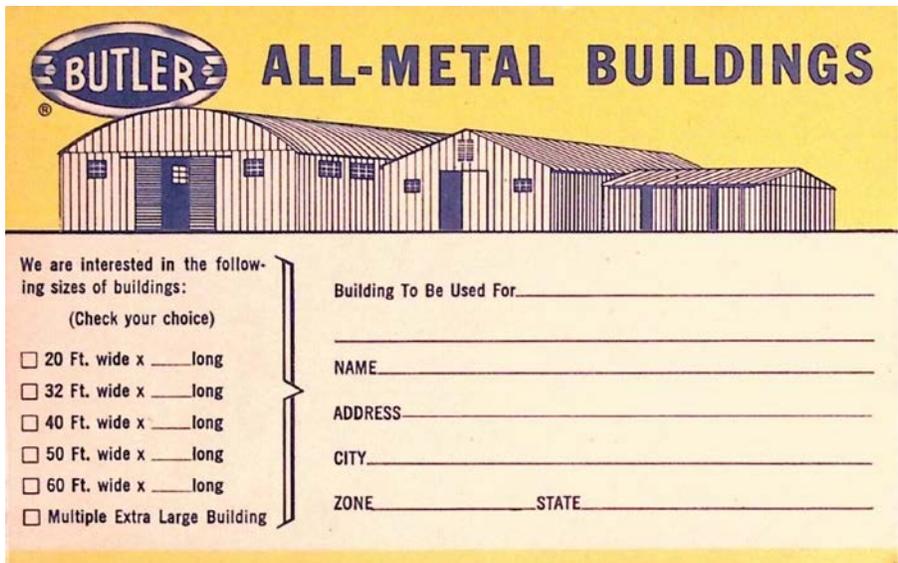
Figure 10: A ca. 1950 postcard produced by the Butler Manufacturing Company includes a building that closely resembles the Butler Building at the Home Ranch. (Ebay)

Constructed between 1948 and 1954 based on manufacturing details and historic aerial photographs, the 40' x 100' Butler Building stands facing east, opposite the Feed and Seed Storage Building.<sup>16</sup> The tall one-story, rectangular-plan, pre-engineered steel agricultural building stands on a concrete foundation. The walls are clad with vertically oriented Butler BRI steel panels.<sup>17</sup> The metal panels, manufactured between 1948 and 1959, are stamped with the Butler Manufacturing Company logo. The front gable roof is covered with Butler BRI steel panels, painted red. A replacement overhead garage door sits at the center of the east (front) wall. On the west side, a concrete ramp leads up to tall historic sliding doors clad with Butler steel panels. Historic metal-clad pedestrian doors are found on the north side and south sides. Most of the building's historic six-light steel windows are covered by metal grills.

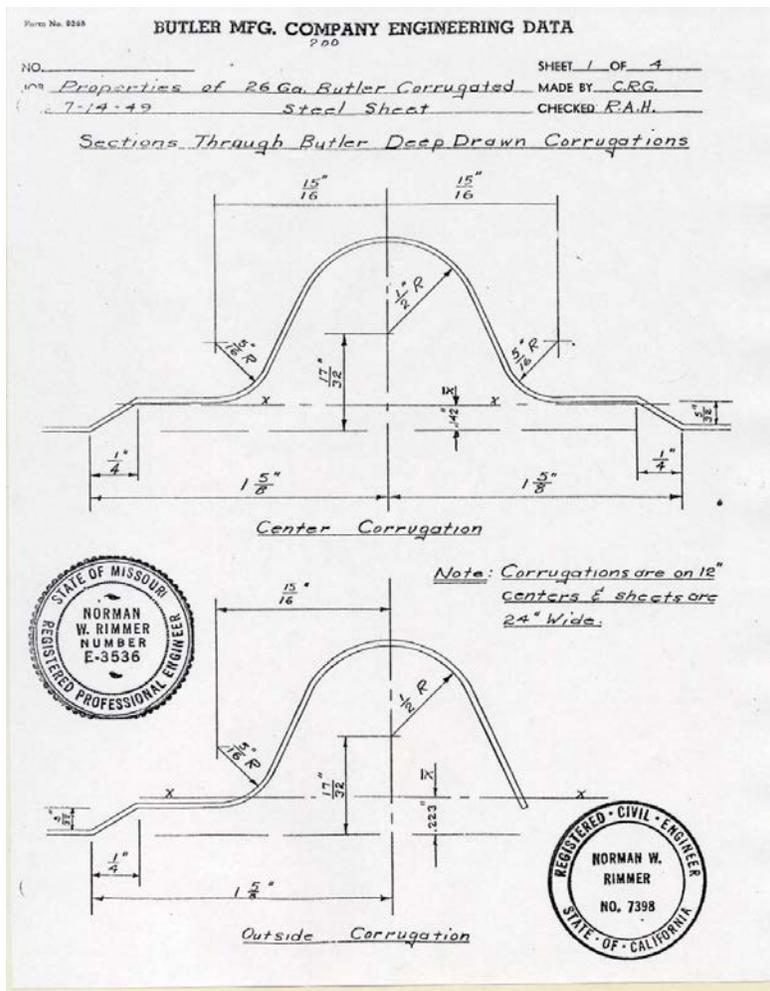
Figure 11: The profile of the steel panels used on the Butler Building match the profile of the Butler BRI Panel manufactured between 1948 and 1959. (butlerpartsonline.com)

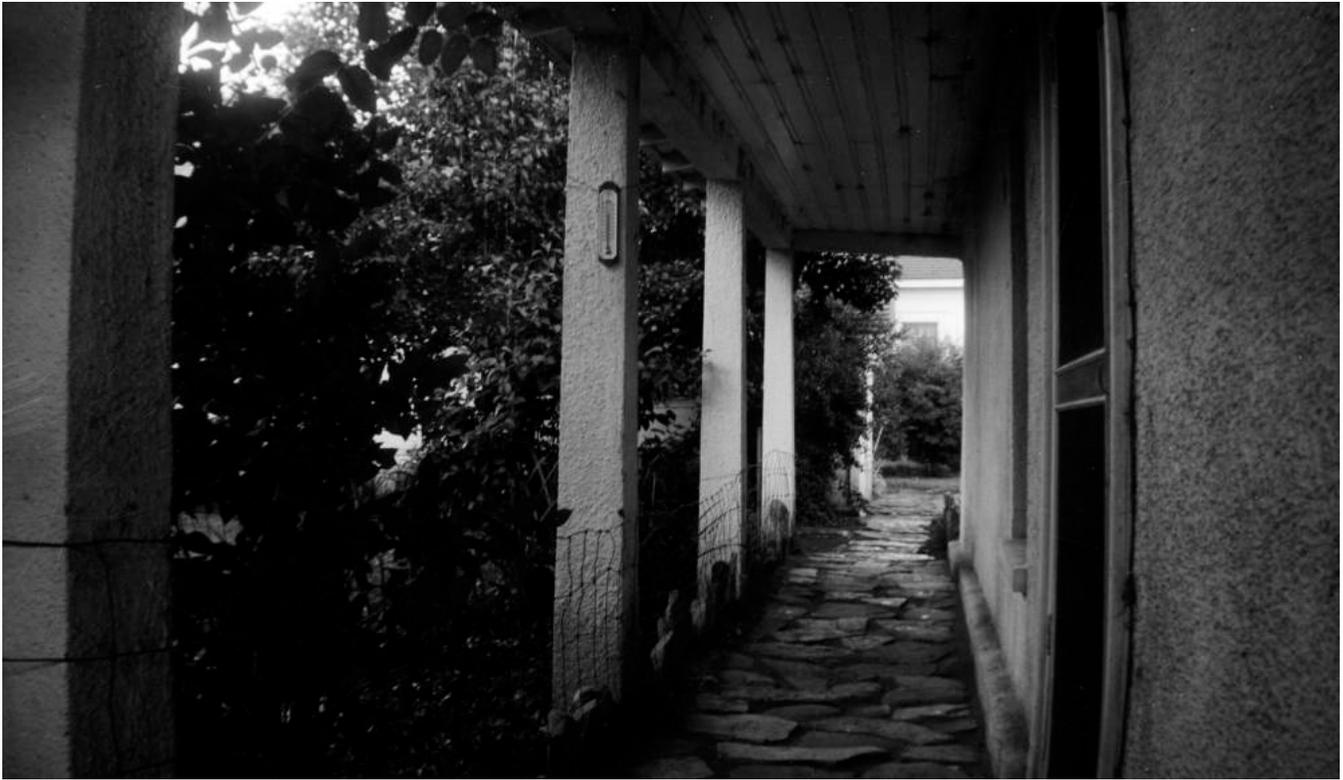
Figure 12: Bunkhouse/Office porch at Home Ranch, 1940-50. (Denver Public Library Special Collection, X-5539)

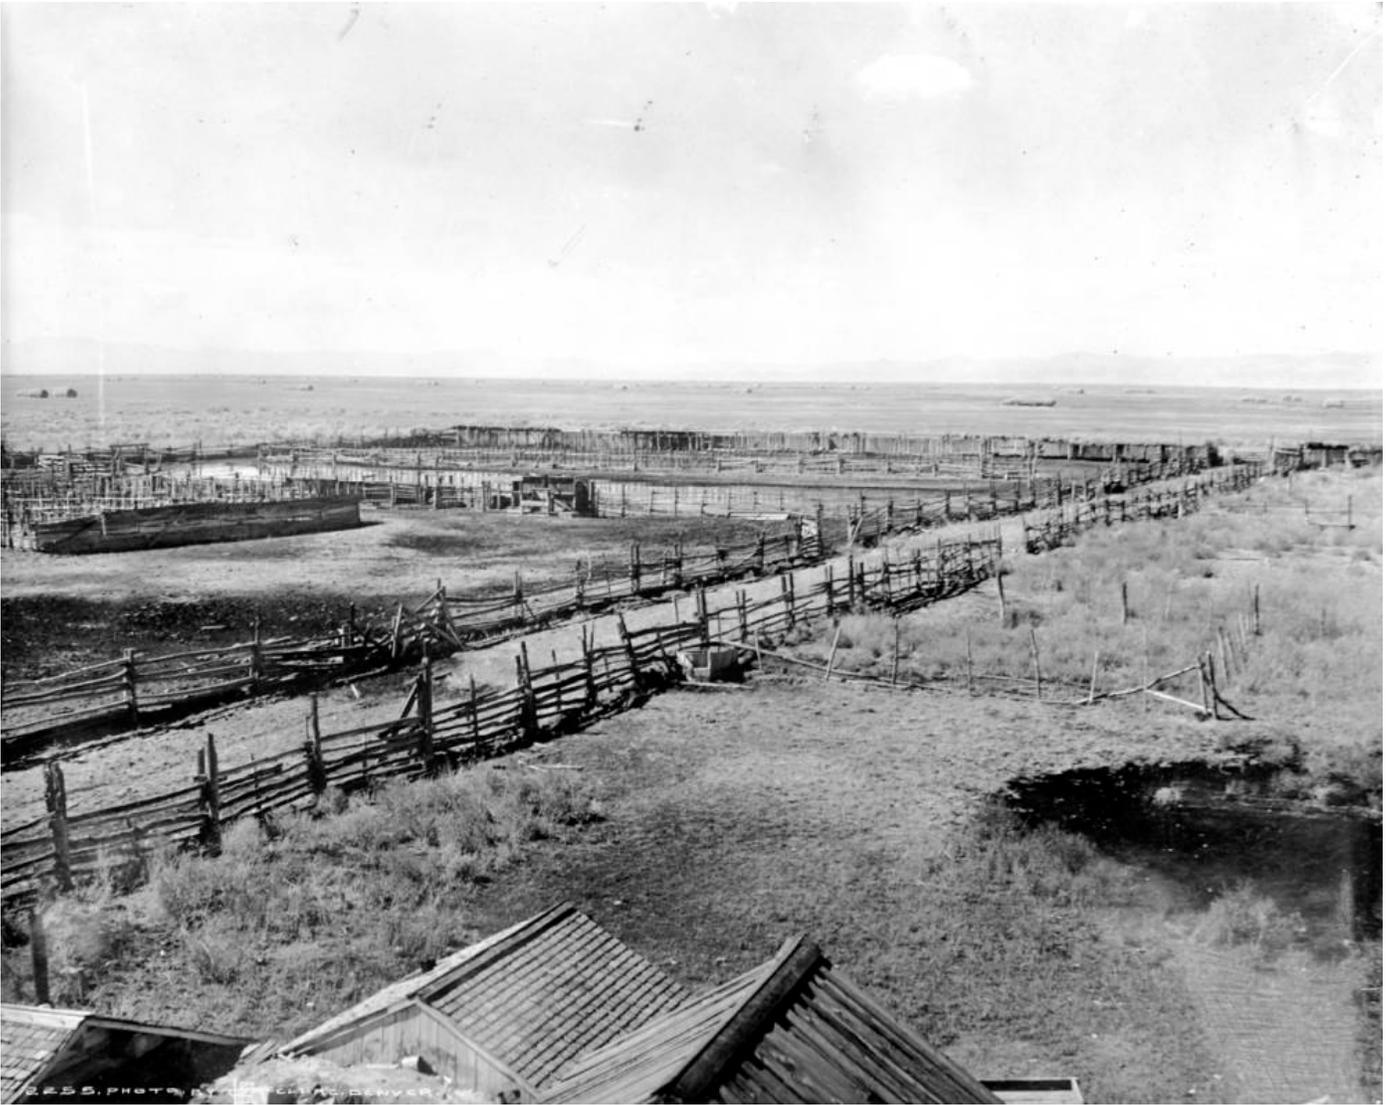
Figure 14: Corral complex on the Luis Baca Grant No. 4, ca. 1920-30, exact location unidentified, likely Willow Camp. (Denver Public Library Special Collection, MCC-4152)

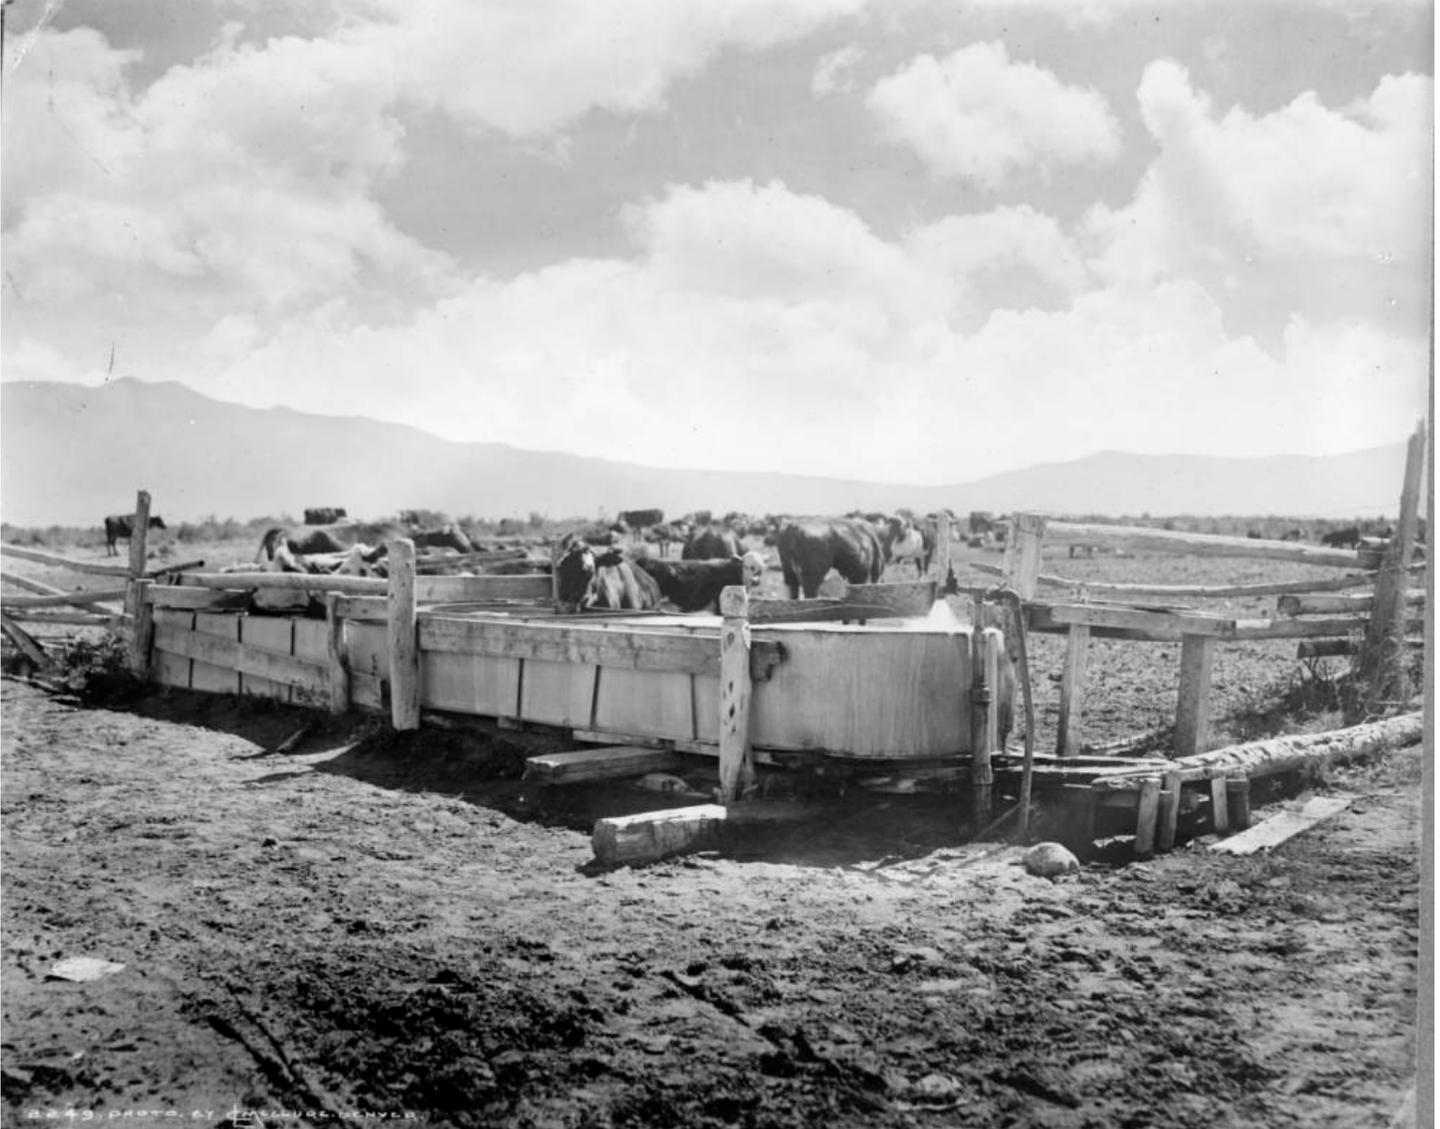
Figure 15: Corral complex on the Luis Baca Grant No. 4, ca. 1920-30, exact location unidentified, likely Willow Camp. (Denver Public Library Special Collection, MCC-4153)

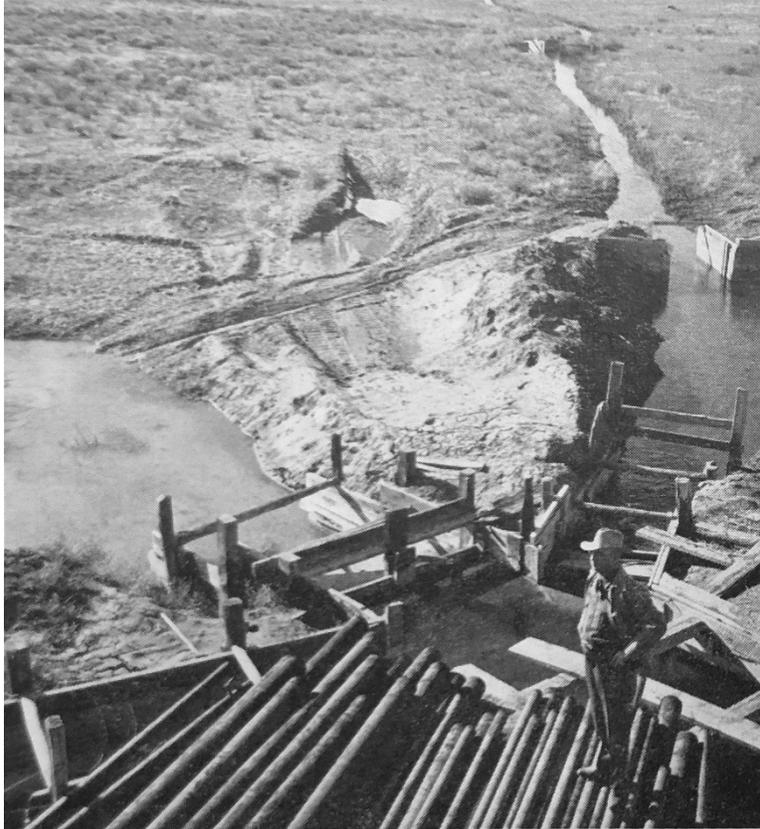
Figure 21: Irrigation head gate on the Baca Grant ca. 1950. (Reprinted from *Baca Grant*, 1950)
